Article

# Acoustic Emission Analysis of Corroded Reinforced Concrete Columns under Compressive Loading

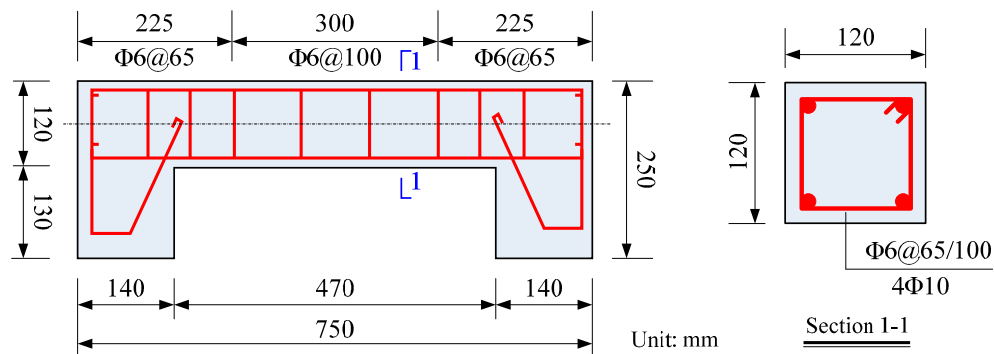
**Figure 1.** Configuration of the specimen (unit: mm), the thickness of concrete covers was 15 mm.

The specimen configuration with the detailed reinforcement layout is shown in Figure 1. Columns were cast in customized wooden molds. After casting for 24 h, the specimens were demolded and then cured in an environmental chamber with  $90\% \pm 5\%$  relative humidity and  $20 \pm 2$  °C for 28 days.

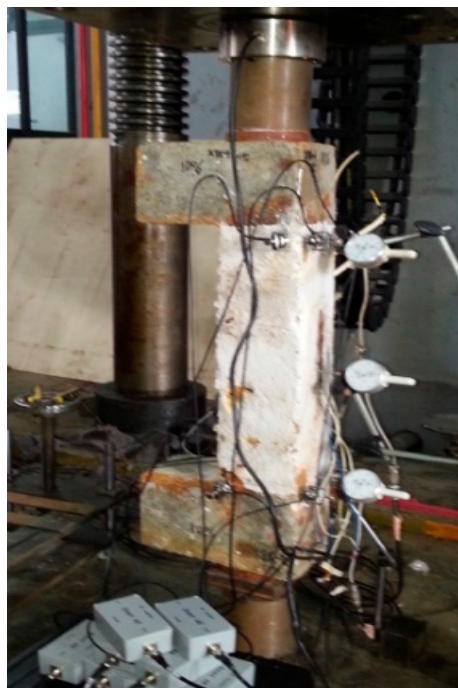
**Figure 4.** Photograph of the test setup.

The monitoring systems including the loading system, AE signal data acquisition system, and the load and displacement recording system are shown in Figures 3 and 4. In particular, the AE acquisition system DS2-8B manufactured by Beijing Science and Technology Company was adopted. Eight RS-35C sensors with a frequency of 150 kHz and 40 dB pre-amplification (parameters suggested in [42]) were used in the AE system. The sampling frequency of the AE acquisition system was 2.5 MHz. To obtain a three-dimensional location of AE events, sensors were attached at the three sides of the columns collecting signals during the whole loading process. Figure 5 shows the spatial arrangement of eight AE sensors on the column specimens.

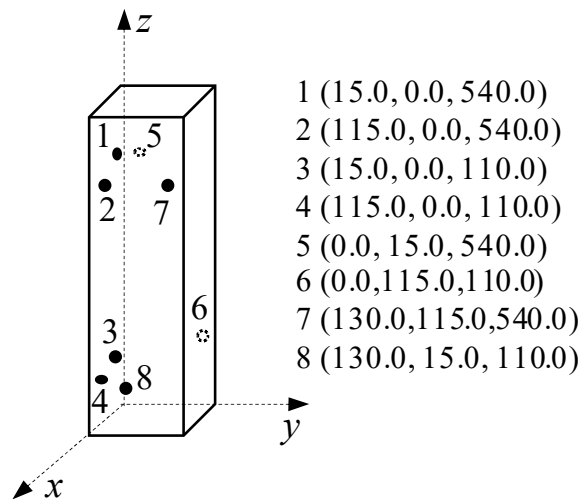
Figure 5. Distribution of AE sensors on specimens.

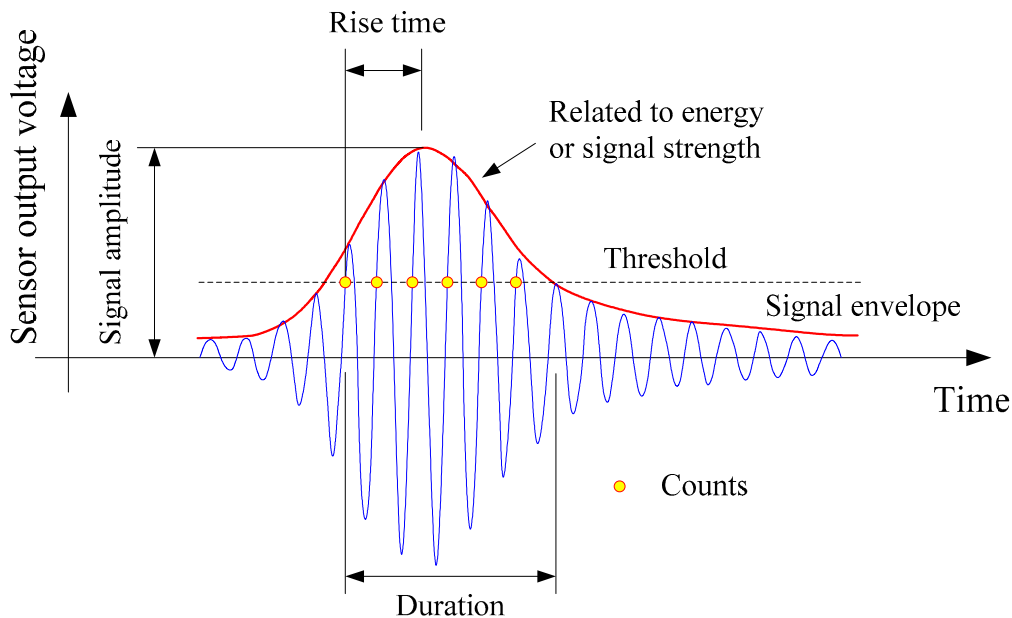
Figure 6. Typical AE signal and its characteristics [44].

The major characteristic parameters of AE include the signal amplitude and energy, hit number, rising time, and duration, with their corresponding physical meanings shown in Figure 6. The parameters can be divided into two categories, namely, intensity and activity. Intensity is used to indicate the strength of the AE signal, mainly characterized by parameters such as amplitude and energy. In general, the greater the amplitude and the higher the energy, the greater the degree of structural damage. While the intensity is used to indicate the frequency of AE signals, reflecting the real-time changes and development of defects, mainly described by parameters such as hit number, hit rate, and cumulative hitting count. The faster the cumulative hitting count growth and the greater the hit rate, the more active the AE signal and the greater the damage development rate.

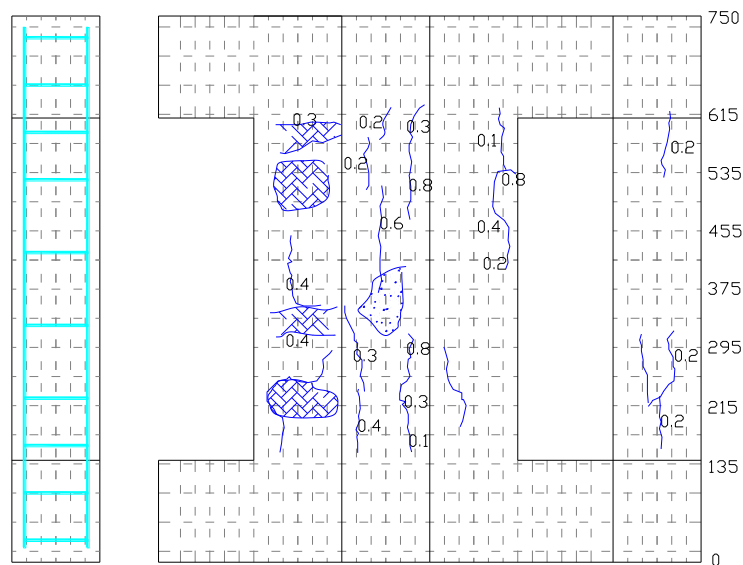
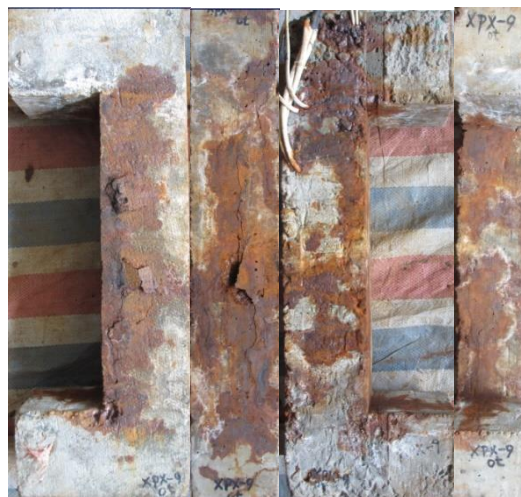
**Figure 7.** Corrosion-induced crack patterns: (a) cracking maps of corroded reinforced concrete (RC) column; (b) distribution of cracks and leakage of rust from reinforcement corrosion on the surfaces of the RC column specimens. Unit: mm.

The cracking behavior of the corroded RC column induced by reinforcement corrosion is shown in Figure 7. It can be seen that the stirrup corrosion leads to the bulging of the concrete cover at the location of the stirrup, while the corrosion of the main reinforcement mainly causes the longitudinal cracks. This is mainly because the concrete cover of the stirrup is comparatively thinner, and the stirrups pose certain constraint effects on the longitudinal rust expansion-induced cracking. It is also evidence that the distribution of corrosion products leakage differs in four sides of the column, which could be attributed to the corrosion process, variation of chloride ions and position of the column, and/or other random factors [16].

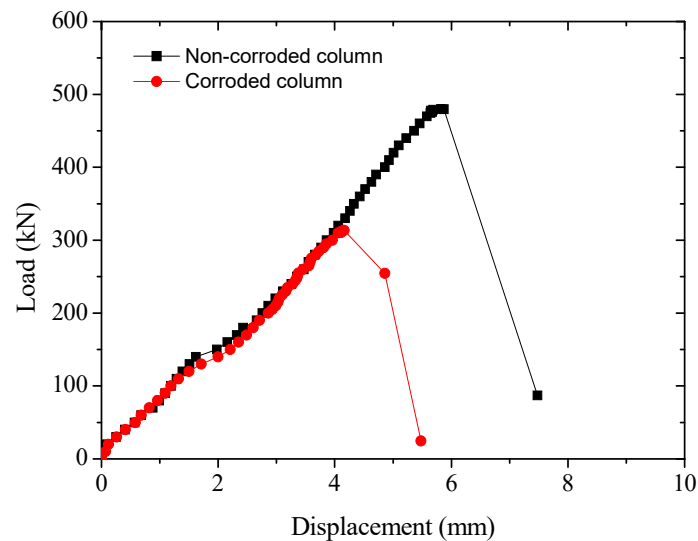
Figure 8. Load-vertical displacement response of RC specimens.

The load-vertical displacement responses of the RC specimens are displayed in Figure 8. It can be seen that the longitudinal displacement of the non-corroded column at failure is greater than that of the corroded column, which is mainly caused by reduction in cross-sectional area of both reinforcements and concrete due to steel corrosion, leading to the reduction of the bearing capacity of the corroded column and accordingly the longitudinal displacement. The failure of both corroded and non-corroded columns shows the typical brittleness modes of a small eccentric column characterized by a sharp drop in load and a further increase in displacement.

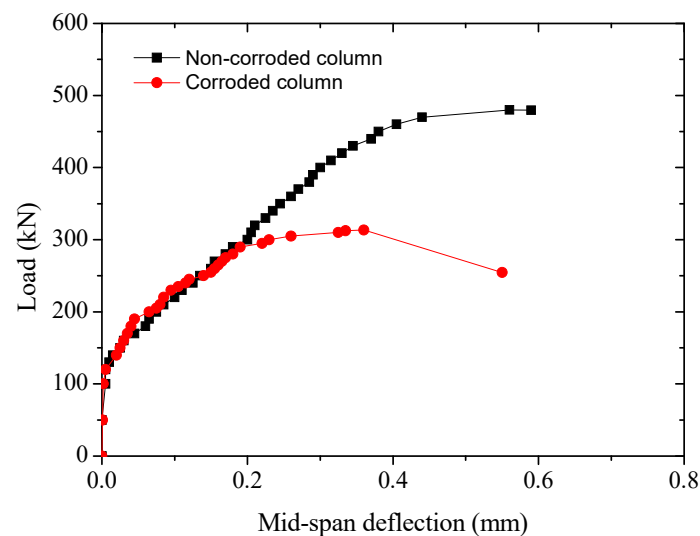
Figure 9. Load-mid-span flexural deflection response of RC specimens.

The load-mid-span flexural deflection responses of the RC specimens are shown in Figure 9. It can also be seen that when the load was small at the initial stage of loading, there was almost no deflection in the mid-span, the phenomenon of which is similar to the axial compression member. When the load was approaching 150 kN, the mid-span lateral deflection began to increase with the increase of the load. Generally, the slope of load-deflection curve of the corroded RC column is smaller than that of the non-corroded RC column.

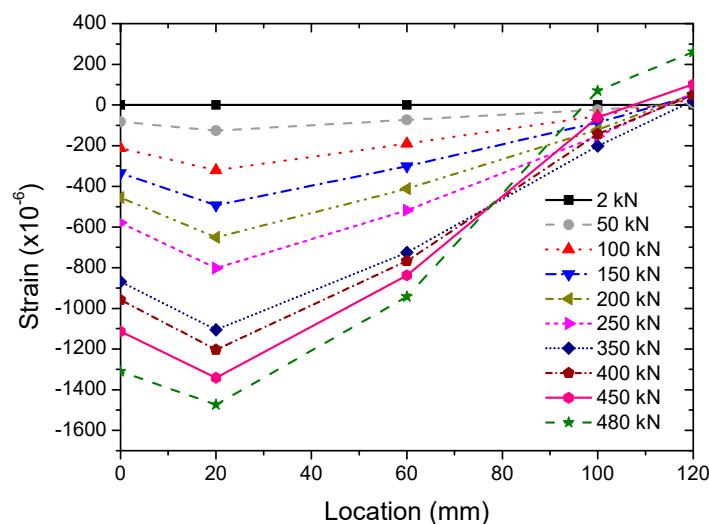
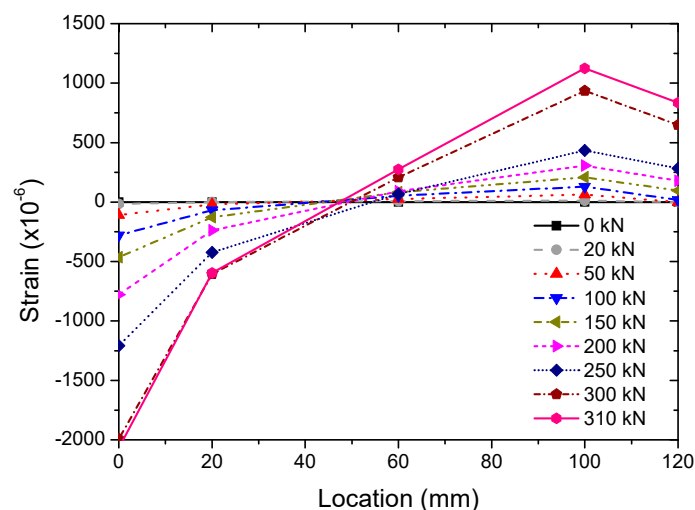
**Figure 10.** Load-strain response: (a) non-corroded column, and (b) corroded column.

The load–strain responses of RC specimens are shown in Figure 10. It can be seen from Figure 10 that regardless whether it is corroded or non-corroded, the cross-section compression zone is decreased with the increase of load, and the strain of the concrete in the core zone conforms to the plane section assumption, increased with the increase of load. However, the difference is that under the same eccentricity, most sections of the non-corroded column were under compressive stress, while for the corroded column the compression zone and the tensile zone were almost the same at the initial stage of loading though they changed with the increase of load. This phenomenon indicates that corrosion has a great impact on the mechanical properties of the column. Due to the corrosion of steel bars, the concrete cover was damaged by rust expansion resulting in a reduction of the effective section, which may lead to the possibility of the failure mode shifting from small eccentricity to large eccentricity.

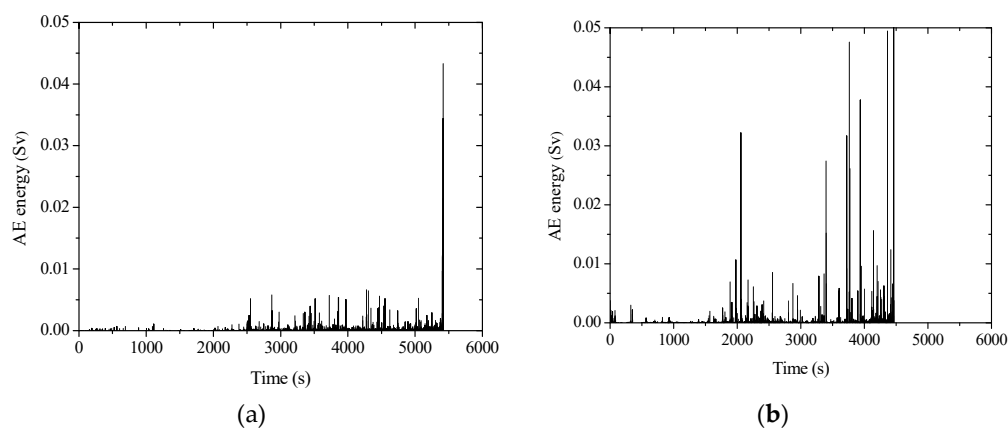
**Figure 11.** AE energy graph: (a) non-corroded column, and (b) corroded column.

Figure 11 shows the time-dependent development of AE signal energy for non-corroded and corroded columns. The corroded column fails earlier than the non-corroded one at the same loading speed. It can be seen that the non-corroded column has little energy release before 2500 s, and the energy begins to release from 2500 s at a relatively low level until the sudden release happened at around 5400 s. However, the corroded column released some energy before 2000 s, followed by a gradual release, and a final sudden energy release at around 4500 s. This is probably because of the pre-existing internal expansive pressure of corroded reinforcement due to a volumetric increase by forming rusts as shown in Figure 12. It indicates that some amount of energy has already been triggered in concrete internally before external loading is commenced. Therefore, the internally stored energy can be easily released in a manner of crack propagation, even when the external loading level is low.

It can be seen that both corroded and non-corroded RC columns experienced a long time of energy release before failure. However, the corroded column shows more energy peaks, as well as higher intensity of peak energy at failure. It is likely due to different failure modes due to reinforcement corrosion. It was observed that for corroded concrete, not only the concrete in the compression zone was severely crushed, the concrete cover was also peeled off in a large area. By contrast, the non-corroded column did not experience any considerable peeling off of its concrete cover, as can be

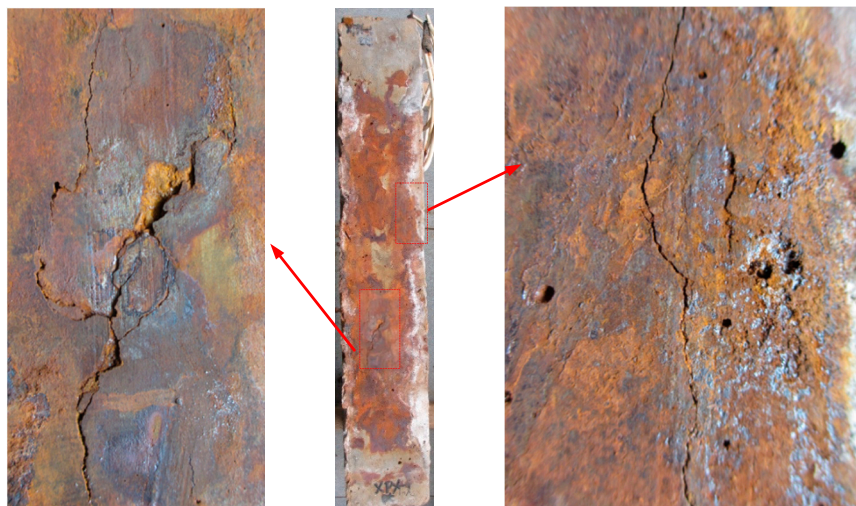
**Figure 12.** Cracks due to volumetric increase by rust formation on the surfaces of the RC column specimens.

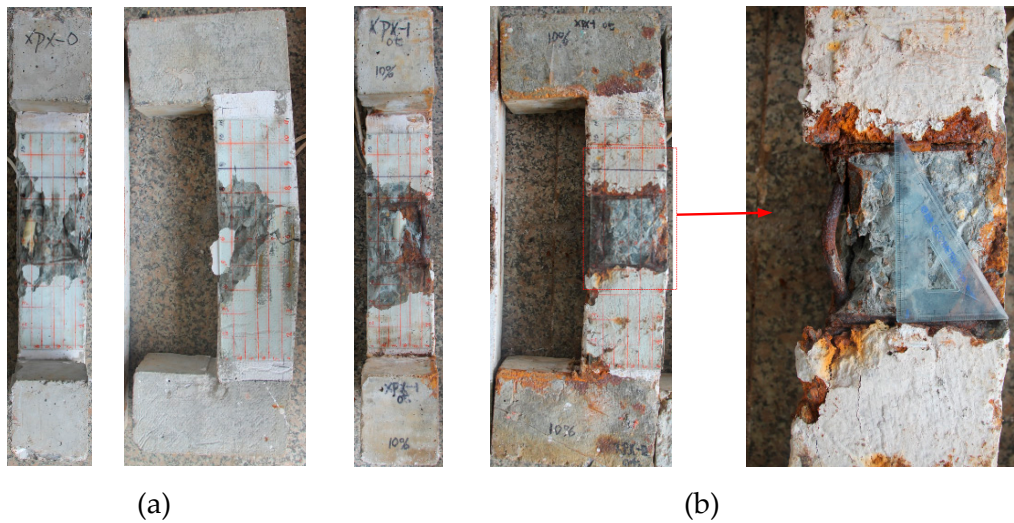
**Figure 13.** Visual observation of failure characteristics at the surface of RC columns: (a) non-corroded column, and (b) corroded column.

seen from Figure 13. Therefore, it is reasonable that more energy of the AE signal was released for the corroded column, although the internally stored energy may be larger for the non-corroded column.

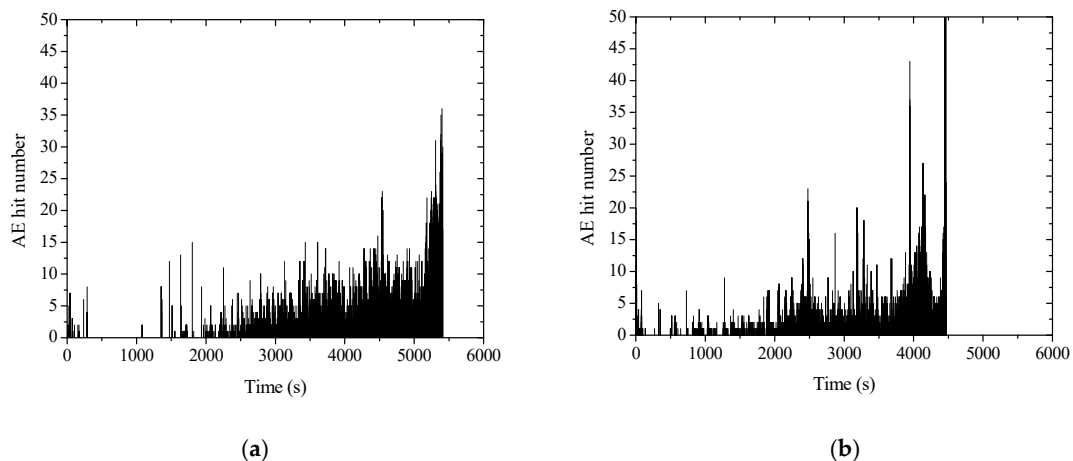
**Figure 14.** AE ring-down count graph: (a) non-corroded column, and (b) corroded column.

Figure 14 shows the time-dependent development of AE hits for non-corroded and corroded columns. It can be seen that continuous AE hits occurred in the entire loading process of the corroded column. However, in the case of the non-corroded RC column, only a small number of AE hits are observed at the initial stage of the loading. Within the period that AE hits were absent, it may indicate that the non-corroded column specimen experienced elastic deformation and no damage was accumulated at that stage. For the corroded column specimens, the steel corrosion has already caused damage and cracking in concrete, which tend to propagate further due to external loading, as can be seen from Figure 15.

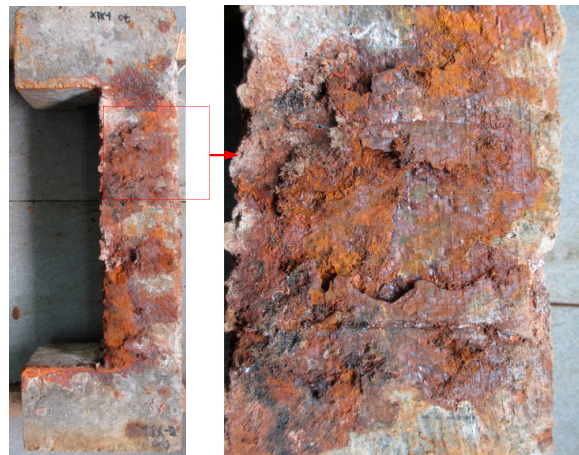
**Figure 15.** The damage in the RC column specimen caused by corrosion of the reinforcement.

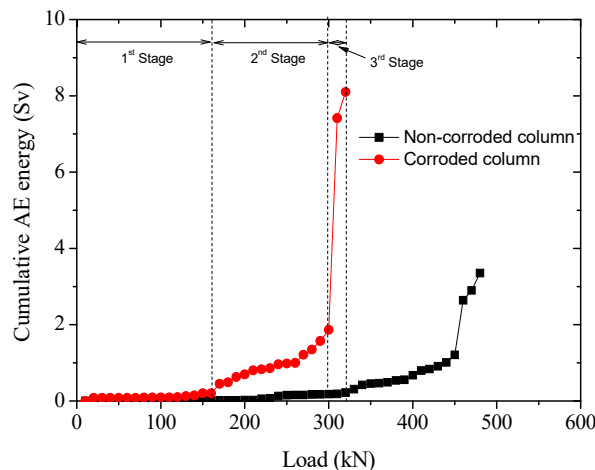
**Figure 16.** Correlation between AE cumulative energy and loads.

Figure 16 plots the relationship between AE cumulative energy and loads, which can be roughly divided into three stages. The first stage occurs at the early loading, in which the cumulative energy remains at a low level, with a gradual increase of the magnitude of the load. In the second stage, the slope of the curve (i.e., the cumulative AE energy per load applied) is increased. The third stage corresponds to a considerably increased curve slope in which the cumulative energy increased rapidly at almost constant load magnitude. The first stage indicates that the internal micro-cracks propagation is relatively slow with deformation energy stored in the materials; the second stage indicates a progressive accumulation of internal damage; while the third stage indicates the coherence of micro-cracks to macro-cracks and final failure.

In comparison to the non-corroded column, the slope of the curve in the second stage of the corroded column is relatively high. This is probably due to the additional energy release upon loading due to the pre-existing stress and damage from reinforcement corrosion. In the third stage, the magnitude of suddenly released AE energy of the corroded column is considerably higher than that of the non-corroded counterpart. For the corroded column specimen, as considerable spalling and loss of surface materials occurred in the second stage, the load was mainly carried by the core concrete. As such, the highly intensive AE that signals release in the third stage of the corroded column is related to the crushing of core concrete.

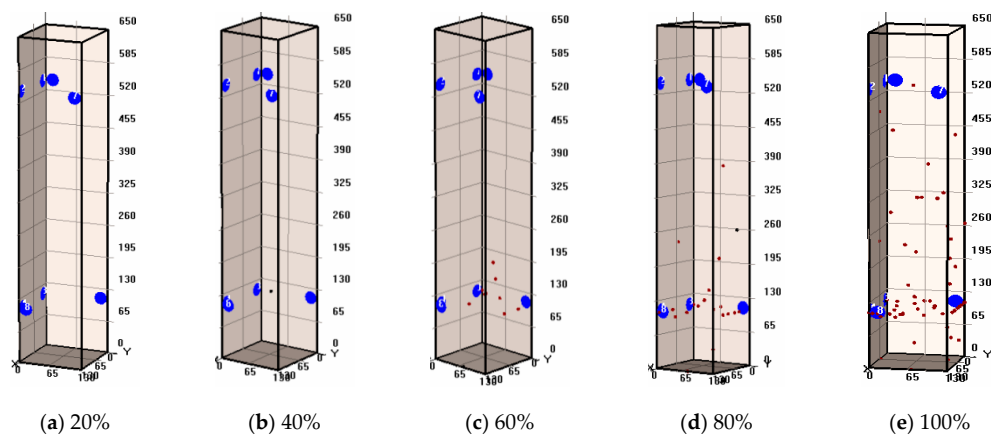
**Figure 17.** Testing results of AE events location at stages for non-corroded specimens with different load levels (a) 20%; (b) 40%; (c) 60%; (d) 80%; (e) 100% load levels.

Figures 17 and 18 show the spatial distribution of AE events of non-corroded and corroded columns under different load levels, respectively. It can be seen that the spatial distribution and evolution of AE events between corroded and non-corroded columns are different. There were more AE events of the corroded column than AE events of the non-corroded column during the whole loading process. Details were illustrated in our previous study [17]. The distinct performance between corroded and non-corroded column is due to the effects of steel corrosion. At the initial loading stage, the pre-existing corrosion-induced micro-cracks can propagate, which is magnified as an AE event. The AE results were in good agreement with the brittle failure mode of RC columns.

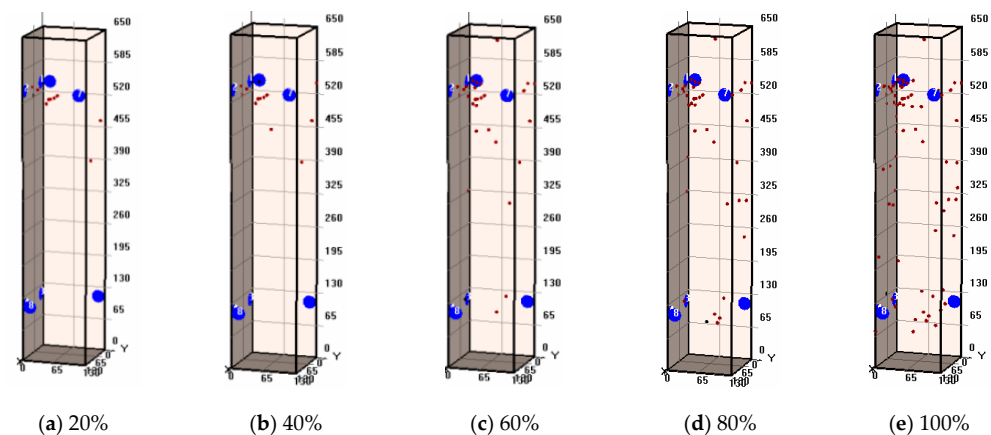
**Figure 18.** Testing results of AE events location at stages for corroded specimens with different load levels (a) 20%; (b) 40%; (c) 60%; (d) 80%; (e) 100% load levels.

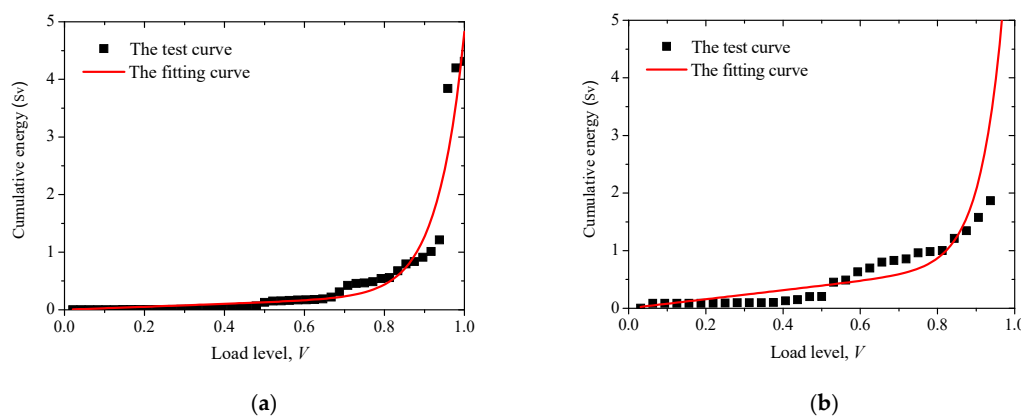
**Figure 19.** Correlation of load level and accumulated AE energy: (a) non-corroded column, and (b) corroded column.

Figure 19 shows the correlation between cumulative AE energy and the load level. With an increase of load level,  $V$ , the cumulative energy of AE increases exponentially. Therefore, the exponential function is proposed to establish the mathematical model of load level and AE cumulative energy value,

$$N(V) = aV + b \exp(cV). \quad (5)$$

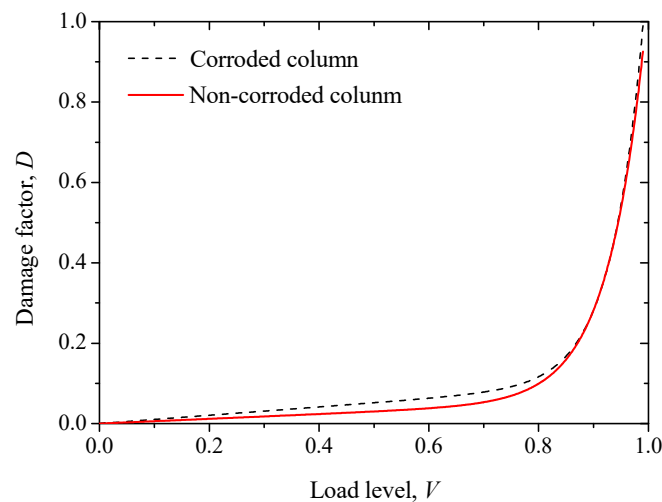
**Figure 20.** The modeled relationships between the load level and the damage factor for corroded and non-corroded RC columns.

Figure 20 shows the modeled correlation between the load level and the damage factor for non-corroded and corroded RC columns. It can be seen that before the 85% load level, the damage

degree is higher in the corroded column, which is in agreement with the test results. Therefore, the damage evolution model of RC expressed by AE energy can be used to describe the corrosion damage of RC columns.
