Engineering Geology xx (2004) xxx–xxx

# A review of landslide problem and mitigation measures in Chongqing (重庆) and Hong Kong (香港) Similarities and differences

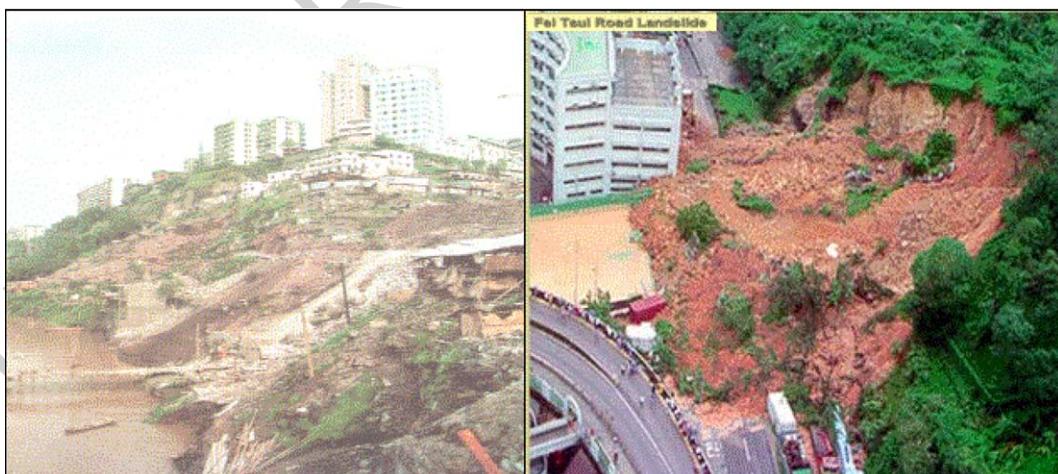
Fig. 2. Landslide in Chongqing and Hong Kong.

slope or earth-retaining structures to populated areas, traffic and building. The landform in Chongqing and Hong Kong is hilly with occupied buildings constructed very close to slopes or on elevated platforms supported by earth-retaining structures. Fig. 2 shows that it is common to have residential buildings constructed at steep slopes and highway located very close to slopes in both cities, because of the scarcity of flat land. A comparison of the percentage of land at different groups of slope angles is presented on Fig. 3. Based on the local experience, the slope at Chongqing is generally stable when the slope angle is less than  $20^\circ$  or greater than  $50^\circ$  (Shu and Hu, 1998). A similar observation can also be found for the slope in Hong Kong. The same observation is consistent to the fact that for a slope which has an angle greater than  $50^\circ$ , it is most likely that it is a rock slope with failure occurrence much less than of a soil slope due to the higher shear strength of the rock mass (Fig. 3 in Hu, 1995).
