STRENGTHENING OF RC SLABS WITH LARGE PENETRATIONS USING ANCHORED FRP COMPOSITES

S.J. Kim^{1,2} and S.T. Smith²

¹Centre for Built Infrastructure Research, University of Technology Sydney, Australia

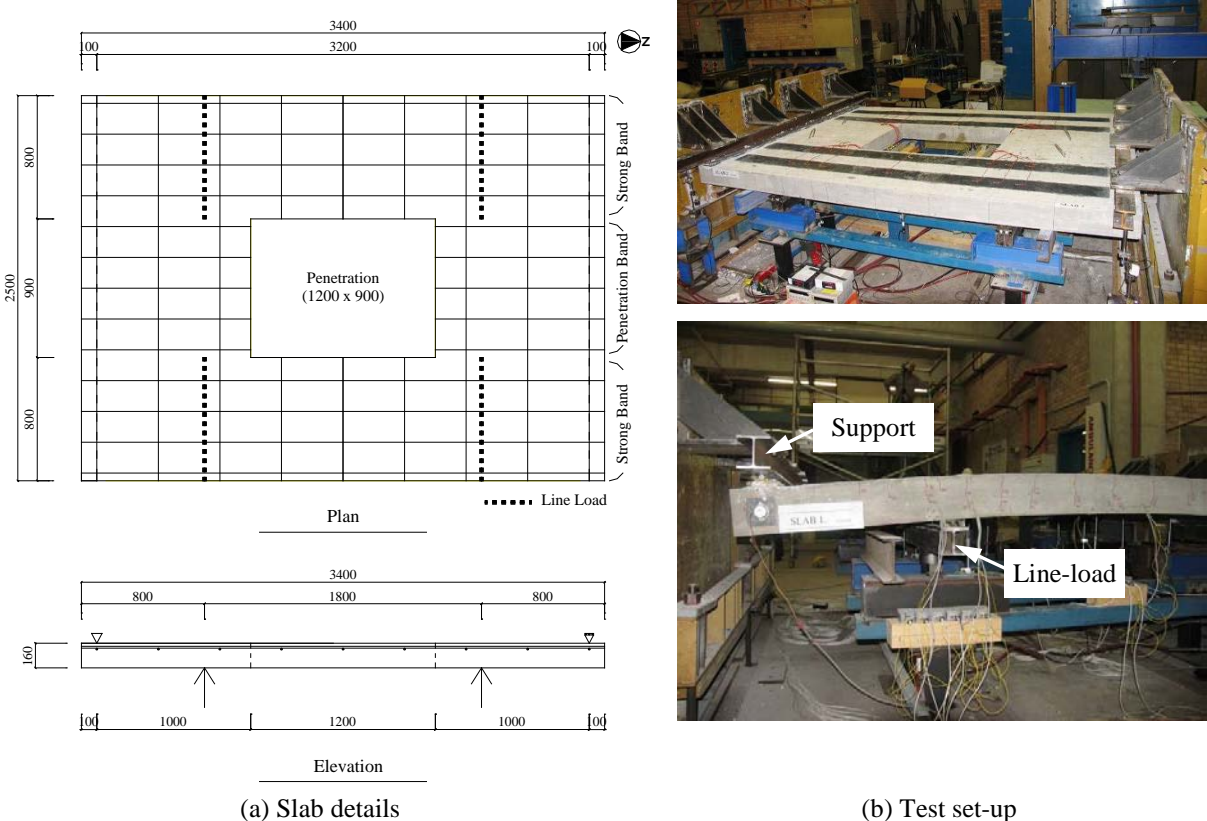
Figure 1. Test slabs

The tested three inverted simply-supported one-way spanning RC slabs (Slabs S1, S2 and S7) are shown in Figure 1. All slabs were prismatic, rectangular in cross-section, and nominally 3400 mm long, 2500 mm wide and 160 mm deep with a clear span (distance between supports) of 3200 mm. The slabs had penetrations of 900 mm width (parallel to the supports) and 1200 mm length and the penetrations were located in the constant moment region produced by line loads applied to the strong bands as shown in Figure 1.

The three slabs were constructed from two different pours of ready-mix concrete. The tested cylinder compressive strengths at the time each slab test being 42 MPa (Slabs S1 and S2 from batch 1) and 35 MPa (Slab S7 from batch 2). All slabs were reinforced with ductile hot-rolled deformed steel reinforcing bars of 12 mm diameter (AS/NZS4671 2001) of which the test yield strength and elongation at fracture were 546 MPa and 10.5 % for Slabs S1 and S2, and 606 MPa and 10.0 % for Slab S7 respectively. The ultimate moment capacity of the slab in the transverse direction was approximately half the capacity of the slab in the longitudinal direction without the effect of FRP considered. The FRP strengthening scheme for slabs S2 and S7 is shown in Figure 2. Also shown in Figure 2 is the FRP anchor layout for Slab S7. The FRP plate consisted of two layers of carbon fibre sheets of 0.117 mm nominal thickness each and 175 mm width. The FRP anchors were applied in a staggered arrangement with the anchor fan component (the part of the anchor bonded into the FRP plate) being orientated in the direction of the unidirectional plate fibres in a bid to optimize the performance of the anchors. The anchor dowel was embedded 40 mm into the concrete slab. Figure 3 shows selected pictures of the FRP plate and FRP anchor application and a much more detailed description of the installation as well as construction of the FRP anchors is given in Smith and Kim (2008).

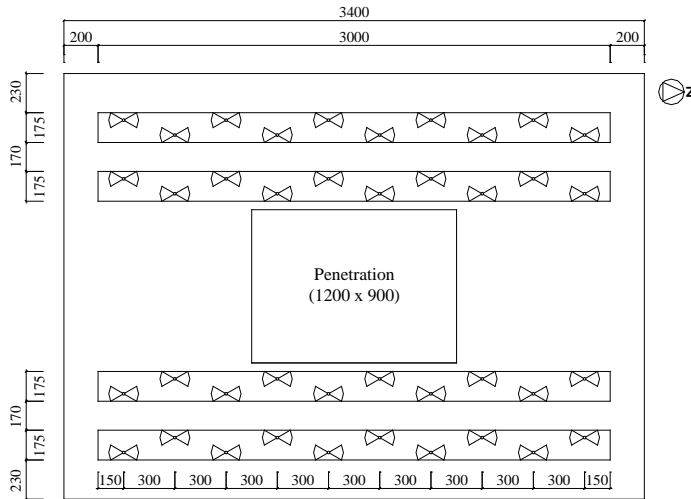
Figure 2. FRP strengthening scheme for Slabs S2 and S7 and anchor layout for Slab 7

(a) FRP strengthening scheme and anchor layout

(b) Detailed view of FRP anchor geometry (Slab S7)

The amount of FRP plate strengthening was calculated based on the loss of steel reinforcement in the penetration region. The calculation of the FRP strength contribution considered IC debonding failure and a detailed description of the analytical procedure is given in Smith and Kim (2009). The effect of the anchors was not considered in the analysis as an IC debonding based analysis was expected to give a lower-bound strength. In order to avoid the internal steel reinforcement interrupting the placement of the FRP anchors, the outermost two FRP strips were shifted toward the penetration region by 30 mm for Slab S7 (i.e. each strip was located 230 mm away from the free edges of the slab for Slab S7 while this distance was 200 mm for Slab S2). In addition, the shear strength of the strengthened slabs was calculated to be sufficient. Eighteen FRP coupon specimens were tested in accordance with ASTM (2000) then averaged to produce mechanical properties of the FRP of elongation at rupture = 10,405 $\mu\epsilon$ (standard deviation, sd. = 1785 $\mu\epsilon$), tensile strength = 2735 MPa (sd. = 156 MPa) and elastic modulus = 268 GPa (sd. = 46 GPa).

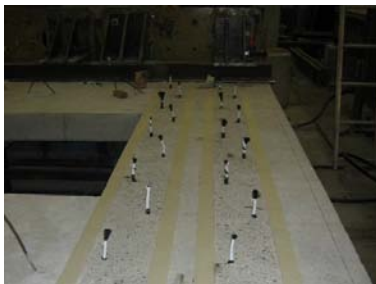
(a) Inserted FRP anchors and prepared concrete surface

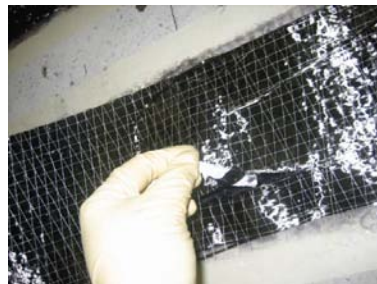
(b) Passing parted sheet fibres over FRP anchor

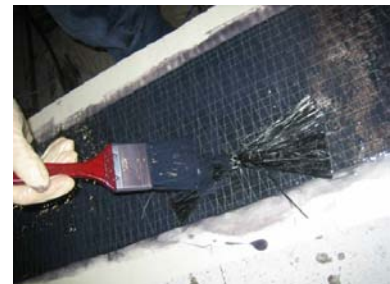
Figure 3. Installation of FRP strengthening and FRP anchors for Slab S7

(b) Splying and epoxying of fan-out fibres onto fibre sheet

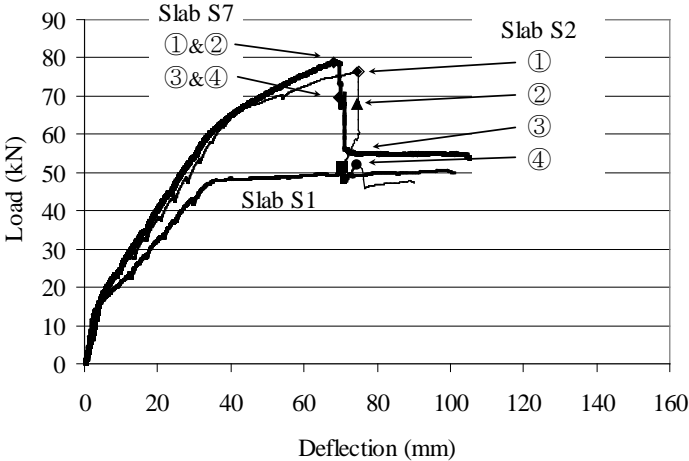
Figure 4. Load- midspan deflection response

The behaviour and failure modes of the three test slabs are described in this sub-section. In addition, a snapshot of the overall behaviour of the three slabs can be seen in load-deflection plots given in Figure 4. In this figure, the beneficial effect of the FRP strengthening can be seen. The contribution provided by the anchors can also be observed.

the intersection of major cracking extending from the corners of the penetration and intersecting with the FRP plates. After loss of the strengthening plate, the behaviour of the slab resorted to approximately that of the unstrengthened control slab S1 as can be seen in Figure 4. Figure 5a shows the sequence of FRP debonding as well as the extent of debonding in each region of the plate. The first portion of strip to debond is indicated as ① and subsequent debonding zones are numbered sequentially. Selected photographs of FRP strips in the process of debonding, extracted from digital video taken during the test, are shown in Figures 5b and 5c. As evident in Figure 5, a large portion of the strip adjacent to the penetration debonded first (i.e. debond ①). As the load was applied directly to each strong band either side of the penetration, the strip adjacent to ① then debonded (i.e. debond ②). The two remaining strips on the opposite side of the penetration then debonded. Upon debonding of ①, the load carrying capacity of the slab was compromised as indicated by a drop in the load in Figure 4. Each strong band of the slab either side of the penetration essentially acted independently, indicating the slab acted as a system of independent beams either side of the penetration.

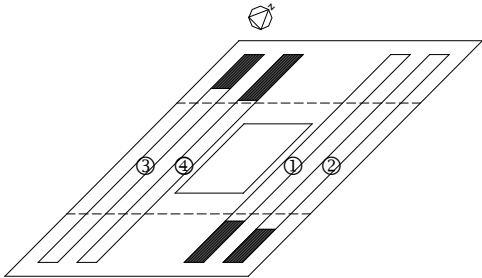
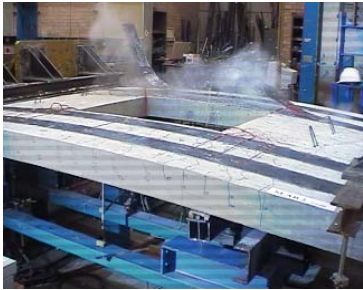
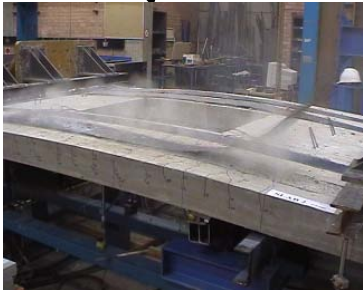
Figure 5. Debonding behaviour of Slab S2

(a) Debonding sequence and extent of debonding

(b) Debond ①

(c) Debond ②

The unanchored strengthened slab failed by IC debonding with the debonding believed to have originated from

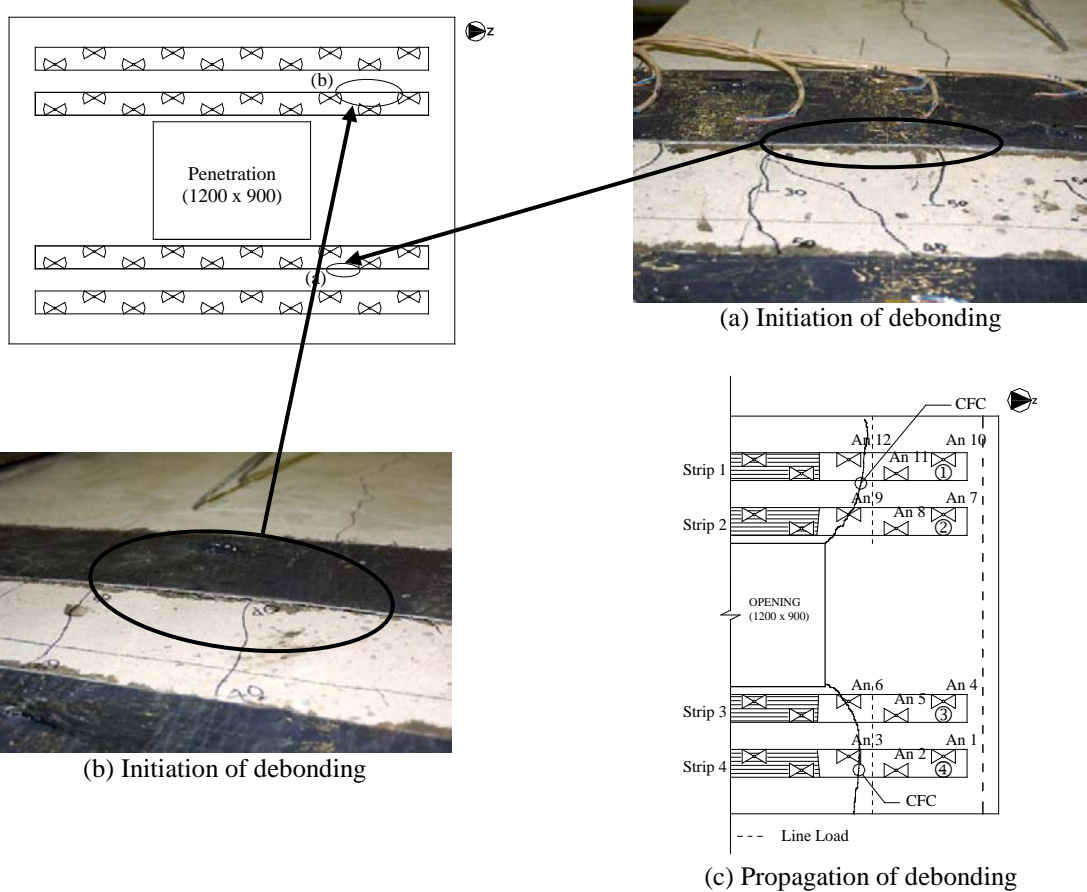
Figure 6. Debonding behaviour of Slab S7

Initiation of debonding was observed around the 60 to 70 kN load range. Localised debonding was observed between anchors at the outer-most side of the plate in the constant moment region as indicated in Figure 6a and extended toward to the plate end as the load increased as indicated in Figure 6b. Figure 6c shows a schematic representation of the debonded portion of the plates and the sequence of debonding (denoted as ① to ④). Two plates (strips 1 and 2; areas ① and ② in Figure 6c) on one of the strong bands debonded one after the other firstly and then the strips on other side of the slab (strips 3 and 4; areas ③ and ④ in Figure 6c). Although all debonded parts of the plates completely separated from concrete surface, all plates were still connected to the anchor fan components of the anchors. As the slab deflection increased, the portion of debonded plate increased and eventually anchors attached to plates failed. Three out of four plates completely separated from the anchor fan while one plate (strip 1 in Figure 6.c) remained attached until complete failure of the slab.

substrate (in the concrete) originated near the region of peak bending moment. Based on test observation as well as analysis of video and data logged data, the anchors in the debonded plate regions stopped the propagation of debonding cracks and effectively held the plates in place until eventual concrete crushing failure. Figure 4 shows the increase in strength offered by the anchors of about 5 % as well as the residual strength of Slab S7 after debonding of the FRP strengthening of about 10 %. Such enhancement of strength is directly due to the anchorage. In addition, this increase post-peak will also be due to friction between the roughened debonded FRP and concrete surfaces. It is hypothesised that stronger and stiffer anchors will increase the residual strength of the debonded system. The optimal result would be to have a residual strength plateau approximately equal in magnitude to the peak load. If such a behaviour can be attained then the system will have ductility; something which is missing in unanchored strengthening systems but essential for safety.

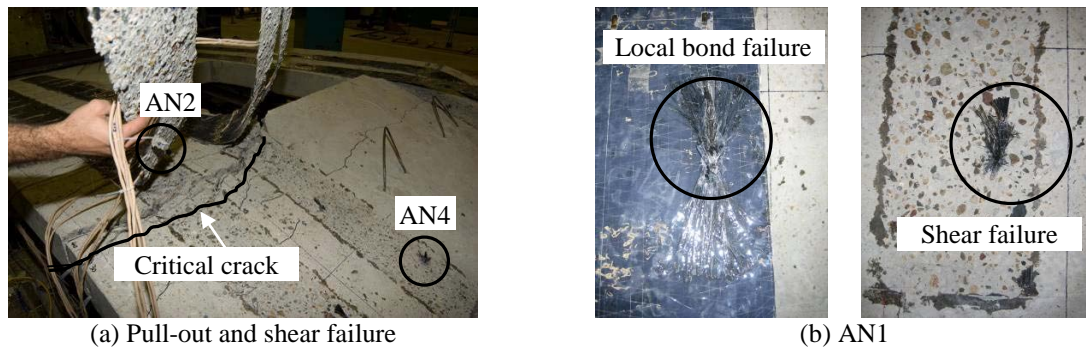
Figure 7. Plate and anchor failure modes of slab S7

The anchors in strips 2 to 4 failed in a pull-out mode (e.g. anchor AN2 in Figure 7a) or a shear mode (e.g. anchor AN4 in Figure 7a). Anchor AN1 was an exception as it failed in a mixed mode of local bond failure between the anchor fan and FRP plate + anchor dowel shear failure as shown in Figure 7b. The anchors generally failed in modes consistent with those observed by Smith and Kim (2008) in anchored FRP-to-concrete joint tests and also by Kim and Smith (2009) on pull-out tests. All the anchors pulling out were located adjacent to or directly in line with wide cracks in the slab. Such cracking severely affected the strength of the anchor.
