Effective restoration of reinforced concrete beams with severe stirrup corrosion using high-strength strain-hardening cementitious composites (SHCC)

ABSTRACT

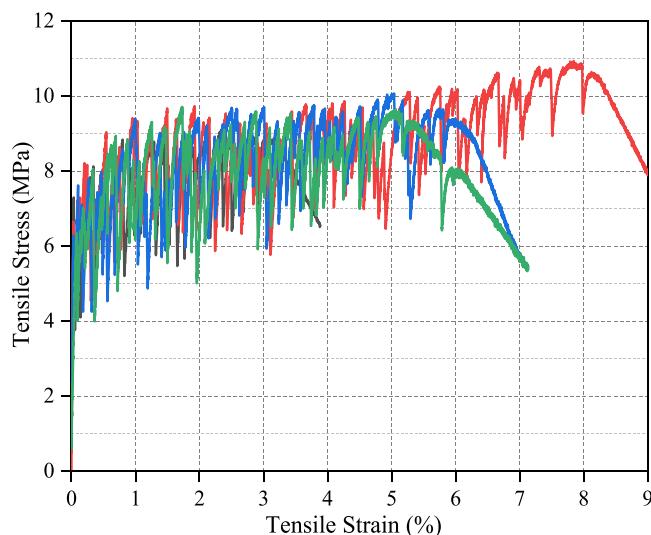
**Fig. 1.** Tensile stress-strain curves of high-strength SHCC under standard curing (after [14]).

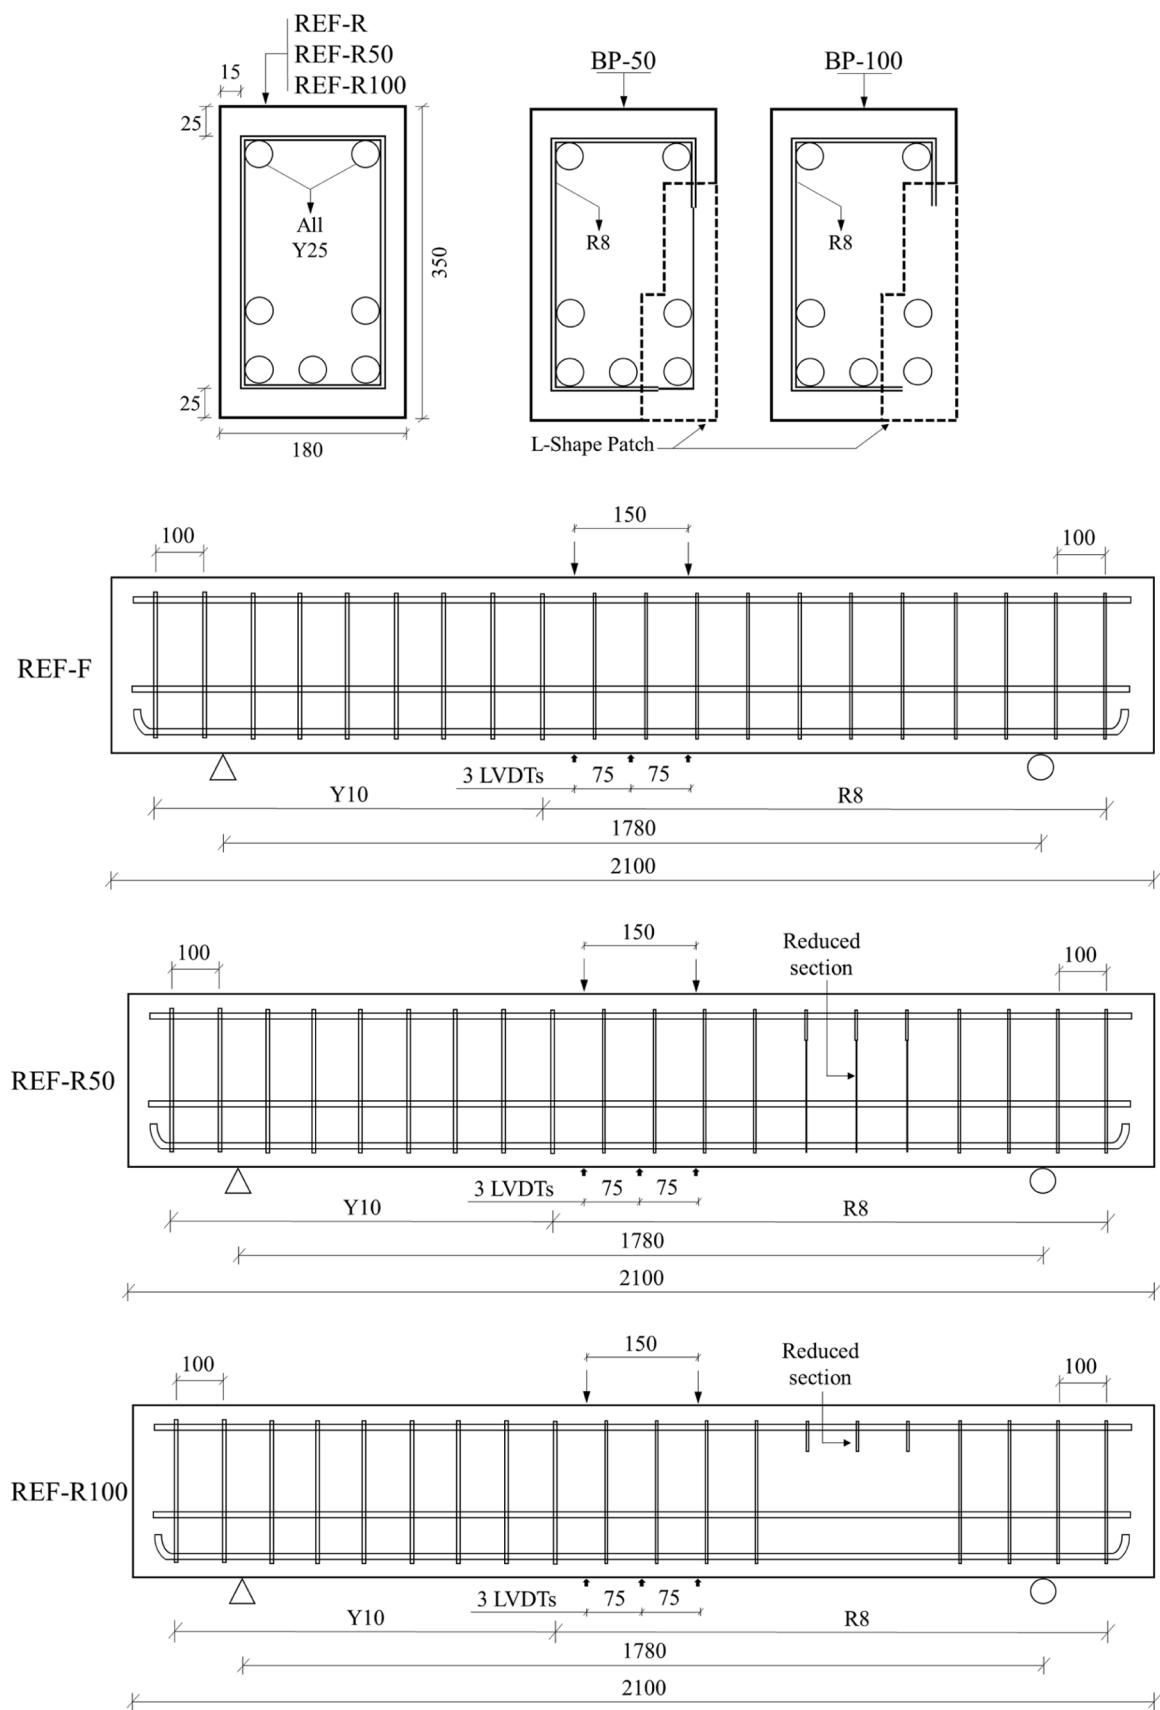
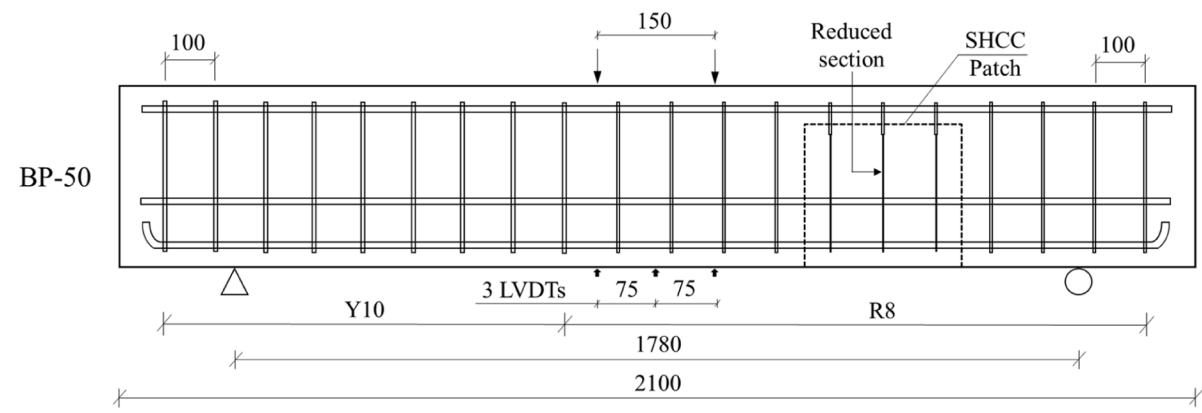
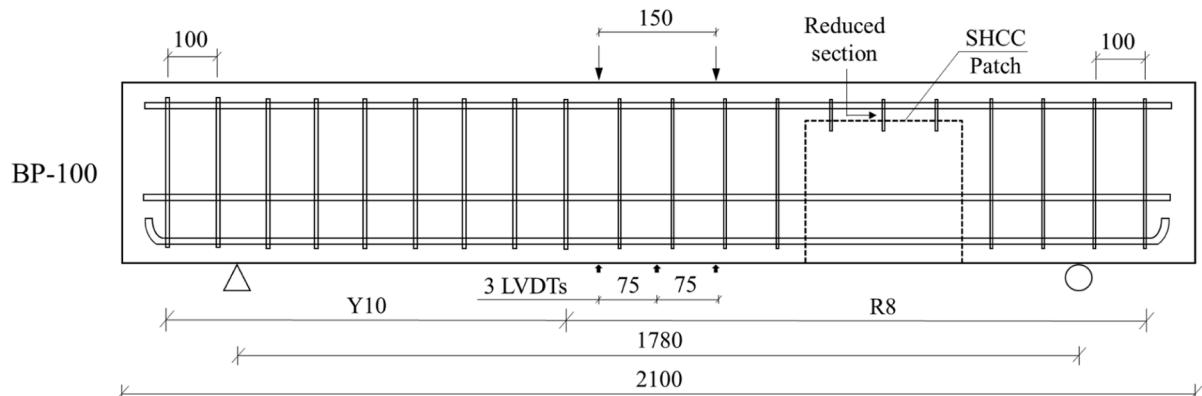
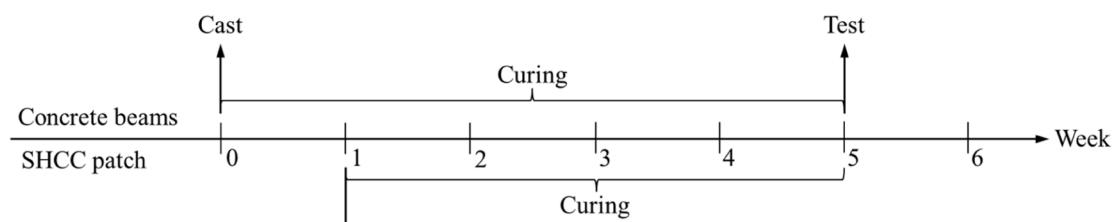
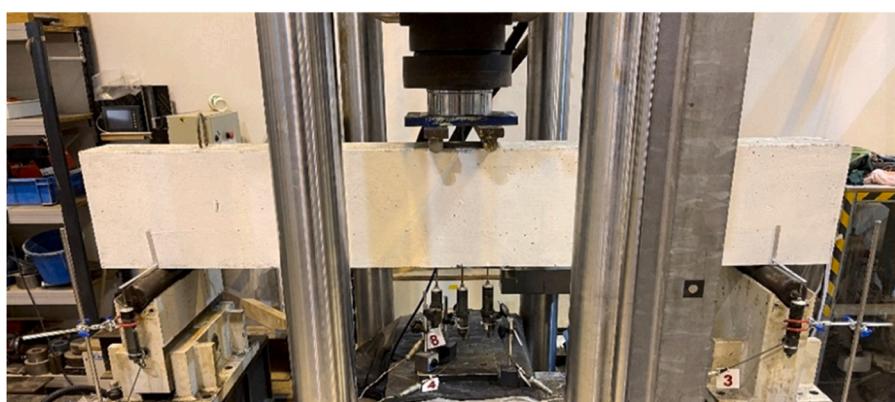
Fig. 2. Four-point bending test: (a) Beam specimen configurations (Units: mm), (b) Process flow chart, and (c) Test setup.

An experimental analysis was conducted on 10 reinforced concrete beams, segmented into three distinct configuration types. Each beam measured 180 mm in width, 350 mm in depth, and 2100 mm in length, as depicted in Fig. 2(a). To prevent flexural failures, the beams were reinforced with five $\varnothing 25$ mm longitudinal rebars (Y25) for tension and two $\varnothing 25$ mm longitudinal rebars (Y25) for compression. The detailed configurations of these test specimens are provided in Table 4. A consistent shear span/depth ratio of 2.5:1 was maintained across all specimens. Reference beams, labeled REF-F, REF-R50, and REF-R100 in

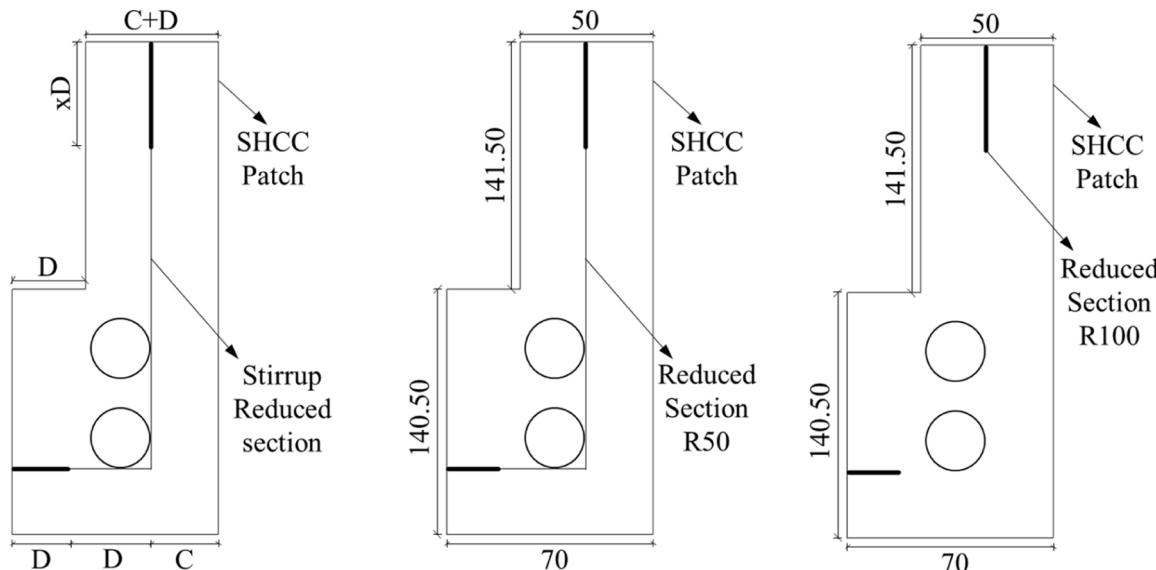
Fig. 3. General geometry of L-shape high-strength SHCC patching (Units: mm).

strength SHCC (illustrated in Fig. 3) and aims at optimizing the repair process. The dimensions "D" and "C" in the design indicate the diameter of the longitudinal rebar and the thickness of concrete cover of the structural element, respectively. To ensure a complete encasement of the rebar with the repair material, a space "D" beyond the rebar is specified, facilitating proper bonding [63]. Additionally, an "xD" space above the rebar—where "x" is a variable yet to be determined—provides the necessary bond length for effective stress transfer. Opting for an L-shaped configuration over a standard rectangular design not only reduces the concrete removal and amount of repair material needed but also enhances the precision in estimating the required strength of the repair mortar.

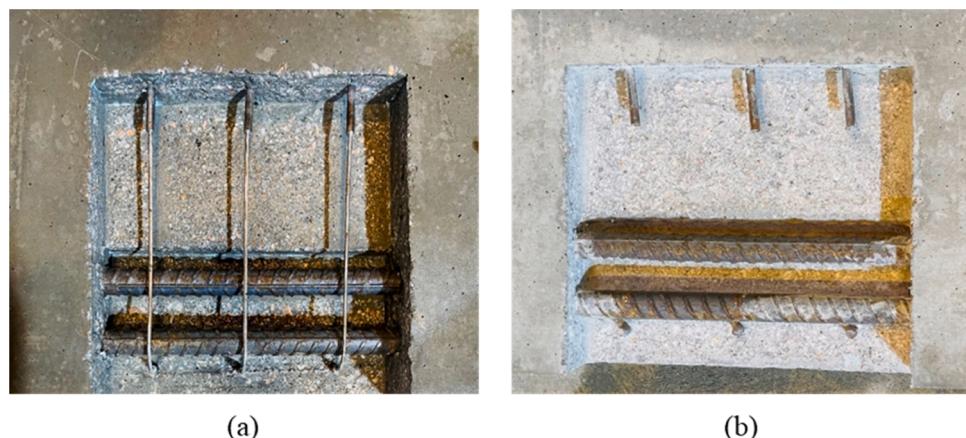
Fig. 4. Roughed surface of RC beam specimens; (a) BP-50 and (b) BP-100.

prior to testing. After a curing period of 7 days, the BP-50 and BP-100 beam specimens were prepared for repair by removing the Plastruct polystyrene foam block. The concrete surface was then meticulously roughened using an air pressure hammer to expose the aggregate, enhancing the bond between the existing concrete and the SHCC patch, as illustrated in Fig. 4. All debris and dust were thoroughly removed to ensure a clean surface for the application of the high-strength SHCC patch. The specific high-strength SHCC was then prepared and cast into the designated voids left in the beam specimens BP-50 and BP-100. To maintain the necessary moisture content for curing, the patch area was covered with a polythene sheet. Following the application of the high-strength SHCC patch, the patched beam specimens BP-50 and BP-100 underwent a further 28-day curing process. This phase involved covering them with wet burlap curing blankets in the laboratory to ensure optimal moisture conditions for the curing of the SHCC patch before proceeding to testing.

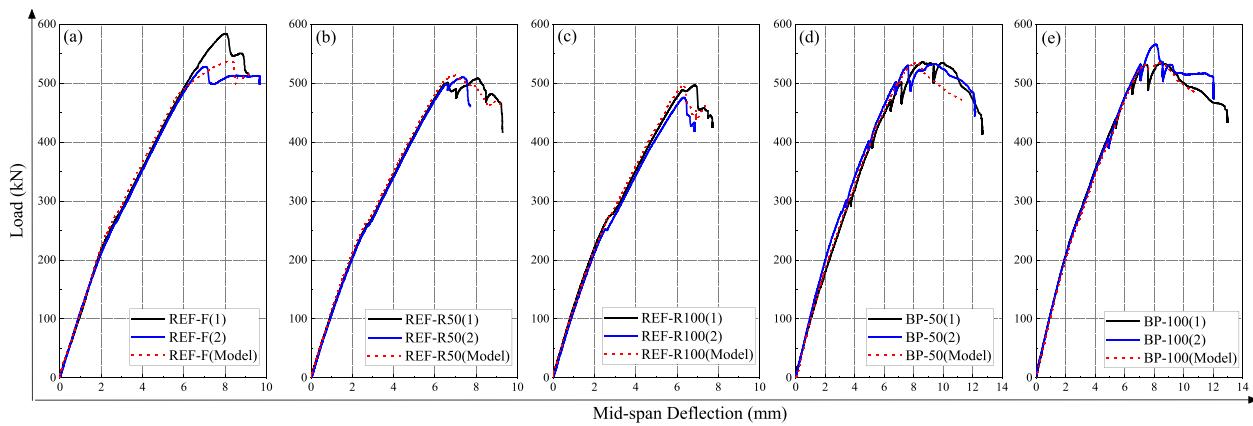
Fig. 5. Load versus mid-span deflection curves of testing and simulation beam specimens; (a) reference beam, (b) reference beam with 50 % reduced stirrup area, (c) reference beam with 100 % reduced stirrup area, (d) patched beam with 50 % reduced stirrup area, and (e) patched beam with 100 % reduced stirrup area.

The results of the load-deflection behavior observed during the four-point bending test are detailed in Table 5, with Fig. 5 illustrating the relationship between load and mid-span deflection for all the beam specimens. The reference beam (REF-F) exhibited an average load-carrying capacity of 555.92 kN. When subjected to a 50 % and 100 % area loss in three adjacent stirrups, the beam specimens REF-R50 and REF-R100 demonstrated load capacities of 509.33 kN and 485.97 kN, respectively. These capacities represent 91.61 % and 87.41 % of REF-F's load-carrying ability. Remarkably, after undergoing repairs with high-strength SHCC, the patched beams BP-50 and BP-100 showed enhanced average load-carrying capacities of 534.36 kN and 549.83 kN, respectively, highlighting the effectiveness of SHCC in restoring structural integrity. Relative to the reference beam equipped with a full

stirrup area, the ultimate load capacities of the patched beams (BP-50 (1), BP-50(2), and BP-100(1)) were restored to more than 96.42 %, 95.82 %, and 96.01 %, respectively. Notably, the BP-100(2) beam achieved full recovery of its ultimate load capacity. An intriguing observation from the study is the significant difference in load-carrying capacities between REF-R50 and REF-R100 beams; however, once repaired with the same high-strength SHCC patch, the repaired specimens, BP-50 and BP-100, exhibited a similar ability to bear loads prior to failure. This similarity suggests that the SHCC's enhanced strain-hardening capability, particularly in scenarios lacking steel stirrups, may play a crucial role, warranting further exploration.

Fig. 5 and Table 5 underline the effectiveness of the FEM in closely approximating the physical behaviors of the beam specimens under load. These outcomes, both experimental and numerical, underscore the effectiveness of employing high-strength SHCC for repairing beams with significantly corroded stirrups. The high percentage of load recovery observed indicates that SHCC repairs can nearly restore the structural capacity of corroded reinforced concrete beams to their original strength, highlighting SHCC's potential as a robust repair material in structural engineering applications.

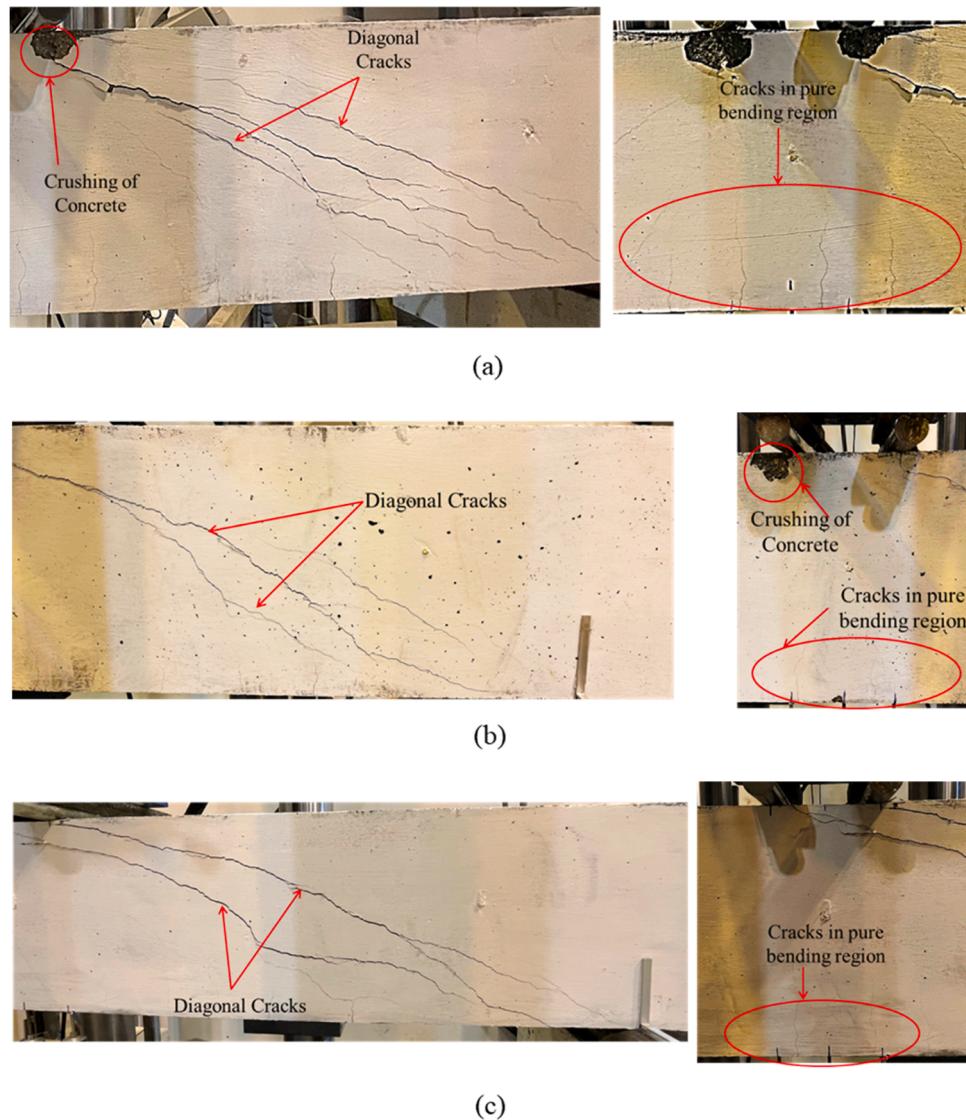
Fig. 6. Crack pattern of beam specimens; (a) REF-F, (b) REF-R50, and (c) REF-R100.

Fig. 6 illustrates the cracking patterns observed in beams that did not undergo repair. The reference beam specimen REF-F, as shown in Fig. 6 (a), exhibited a characteristic cracking pattern typical of members subjected to four-point bending tests. This included minor flexural cracks within the pure bending zone and the initiation of some diagonal shear cracks at the onset of testing. As the applied load was increased, these shear diagonal cracks expanded, while the longitudinal rebars effectively restrained the flexural cracks from widening in the pure bending region, showcasing the reinforcement's high yield stress. For the REF-F beams, failure was primarily due to shear tension within the beam's weaker span. At the point of ultimate load, concrete crushing was observed in the compression zone near the loading points of the beam specimens, with enlarged diagonal cracks appearing on the weaker side, extending between the loading area and the supports. The beams with reduced stirrup area, designated as REF-R50 and REF-R100, exhibited crack patterns similar to those of the REF series (Fig. 6b and Fig. 6c). However, the presence of a specifically weakened region on one side of the beam, attributable to the diminished stirrup area, led to the yielding of the shear reinforcement. This was followed by the rapid development and spreading of cracks within the weaker span of the specimen. As depicted in Fig. 7 for REF-R100, the specimens with a reduced area of stirrups demonstrated the extension of shear cracks into a significant flexural crack under the weaker span and a bending crack on the beam's top surface over the weakened span.

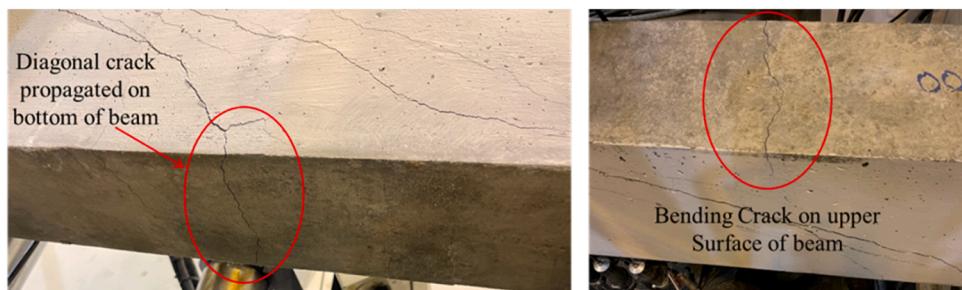
Fig. 7. Major cracks on the top and bottom surface of the REF-R100 beam specimen.

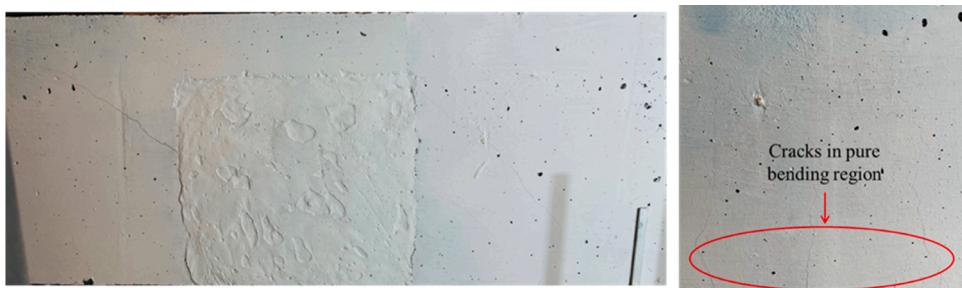
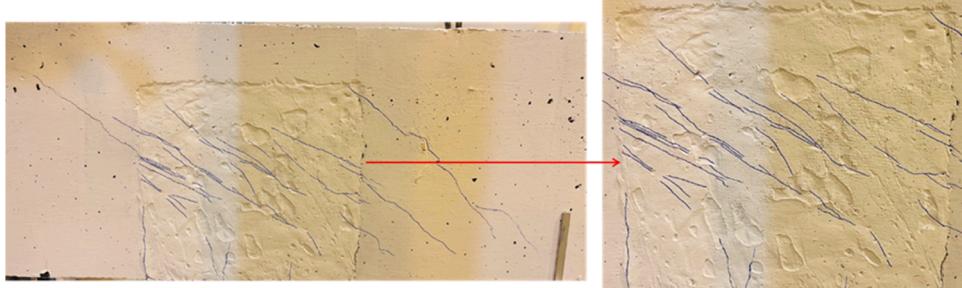
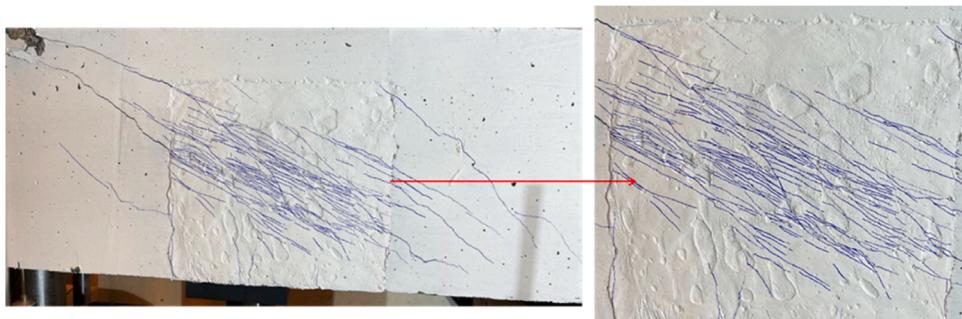
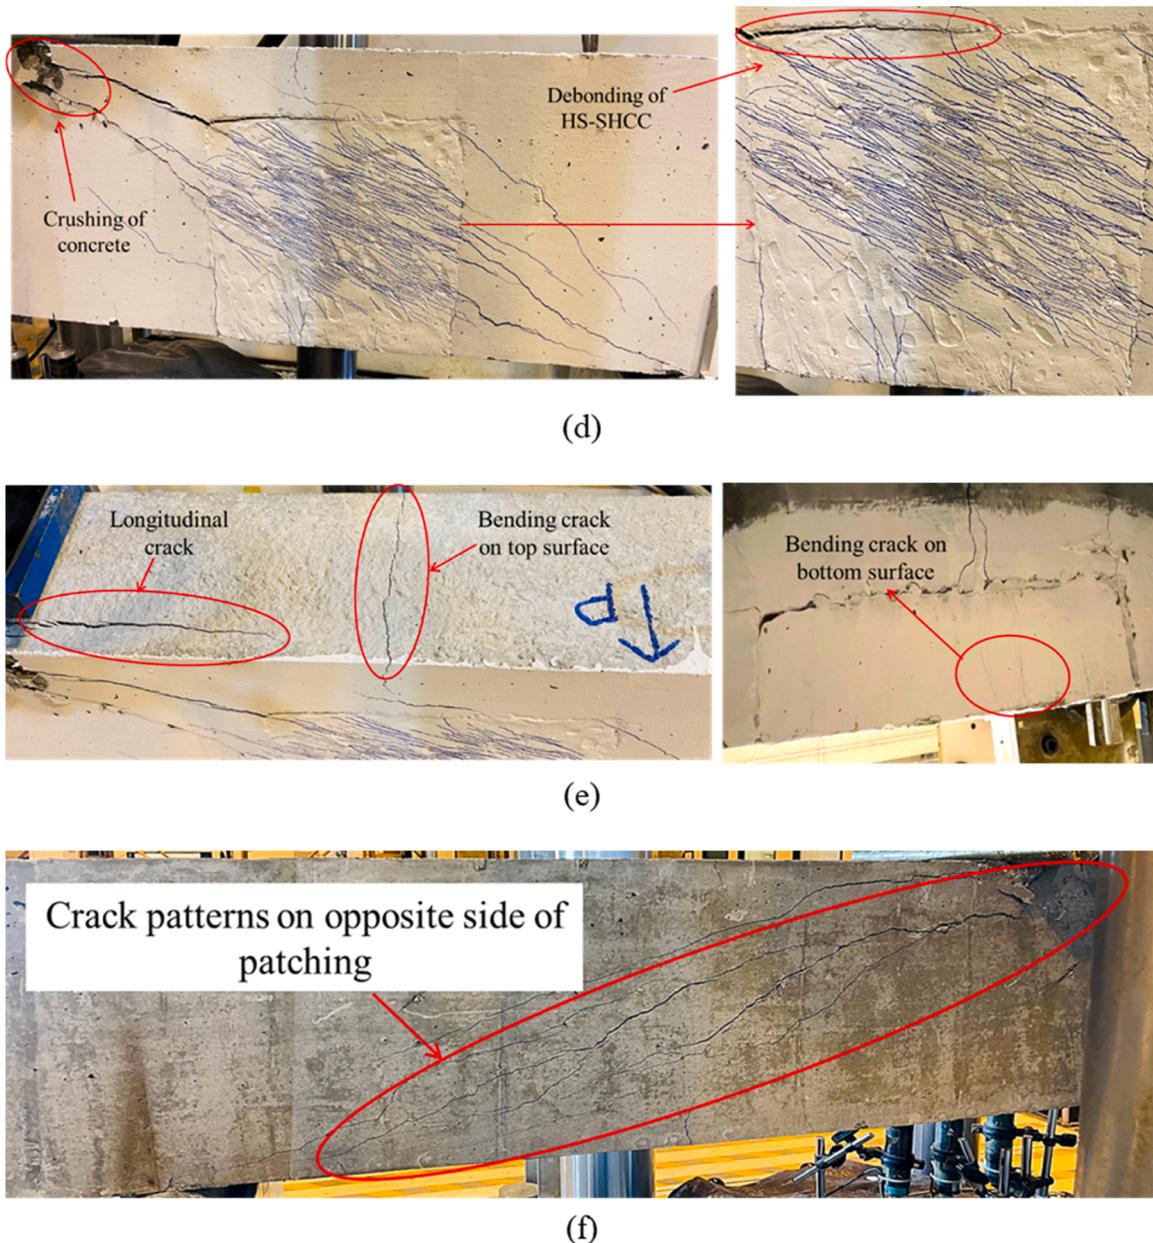
Fig. 8. Crack patterns of BP-50 at different loading points; (a) at 200 kN, (b) at 300 kN, (c) at 400 kN, (d) at ultimate loading, (e) bending cracks on the top and bottom surface of the beam, and (f) crack patterns on opposite to the strengthened side.

For the beams repaired with patches (BP-50 and BP-100), the patterns of cracking are documented in Fig. 8(a-f) and Fig. 9(a-f), with observations of beam and high-strength SHCC crack development at various loading stages (200 kN, 300 kN, 400 kN, and ultimate load) illustrated in Fig. 8(a-f) and Fig. 9(a-f), respectively. At the initial 200 kN loading phase, each of the patched beam specimens exhibited only a few flexural cracks, along with the presence of fine diagonal

strength SHCC patches. Within the SHCC, the formation of multiple fine cracks with small openings was observed, diverging from the typical crack propagation seen in conventional concrete. Upon reaching the ultimate load, an extensive network of fine cracks was noticeable in the SHCC patch. However, failure predominantly manifested as a continuous shear crack stretching from the loading plate to the support. This was particularly evident after the yielding of the longitudinal reinforcement, where a significant shear crack appeared on the upper side of the patch, linking the support to the loading point. Concrete crushing

within the compression zone near the loading point was also observed (as depicted in Fig. 8(d) and Fig. 9(d)). Following the attainment of the ultimate load, a bending crack on the top surface of the beam specimen was evident, as illustrated in Fig. 8(e) and Fig. 9(e).

failure, as illustrated in Fig. 8(f) and Fig. 9(f), bore resemblance to those seen in the unpatched REF-F beam specimens. Upon reaching the ultimate load, minor debonding between the substrate concrete and the high-strength SHCC was noted on the upper part of the patch in both BP-50 (Fig. 8(d)) and BP-100 (Fig. 9(d)) specimens. Notably, a more pronounced debonding crack was detected in BP-100 following the peak load, as shown in Fig. 9(g). The high-strength SHCC in all repaired specimens exhibited multiple cracking behavior, characterized by numerous small openings without any significant cracks, even at the ultimate load. It was observed that the crack density within the high-strength SHCC might vary across specimens with identical configurations. A comparison between BP-50 and BP-100 specimens revealed a greater number of fine cracks in BP-100, where the absence of stirrups to resist shear forces led to more pronounced strain-hardening behavior of the SHCC patch. This suggests that the high-strength SHCC patch plays a more substantial role in enhancing the shear capacity of members that have experienced a complete loss of stirrup area.

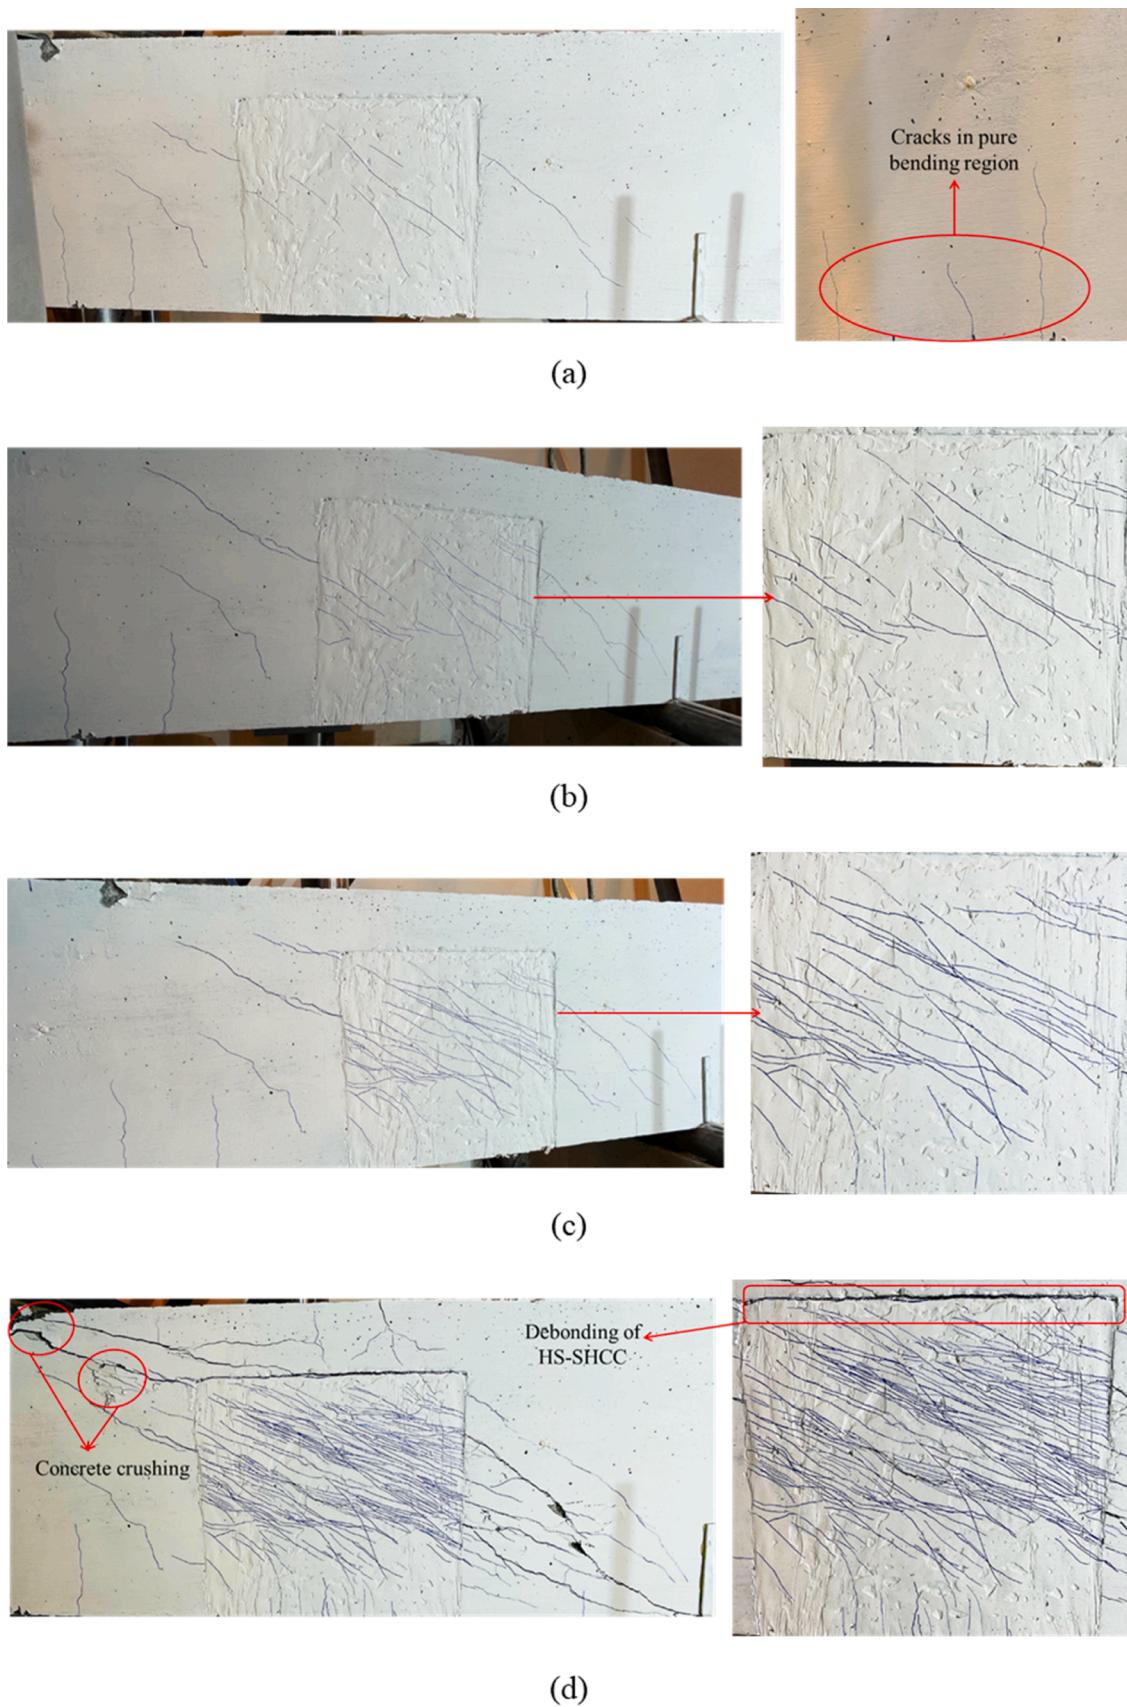
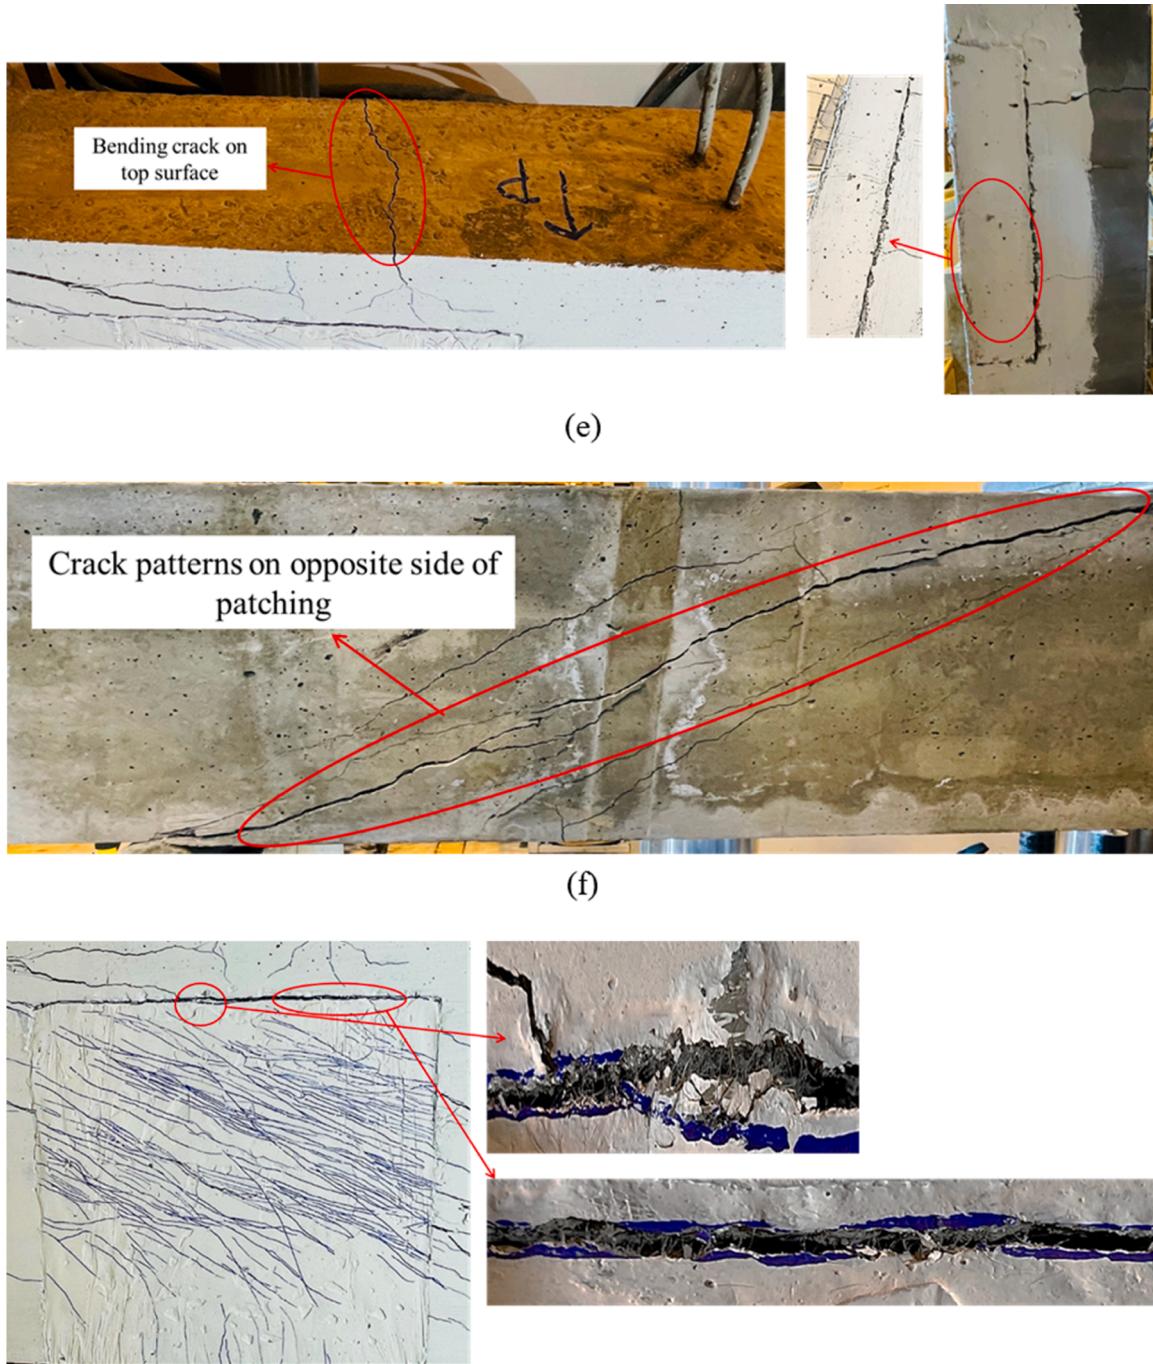
Fig. 9. Crack Patterns of BP-100 at different loading points; (a) at 200 kN, (b) at 300 kN, (c) at 400 kN, (d) at ultimate loading, (e) bending cracks on the top and bottom surface of the beam, (f) crack patterns on opposite to the strengthened side, and (g) debonding of high-strength SHCC.

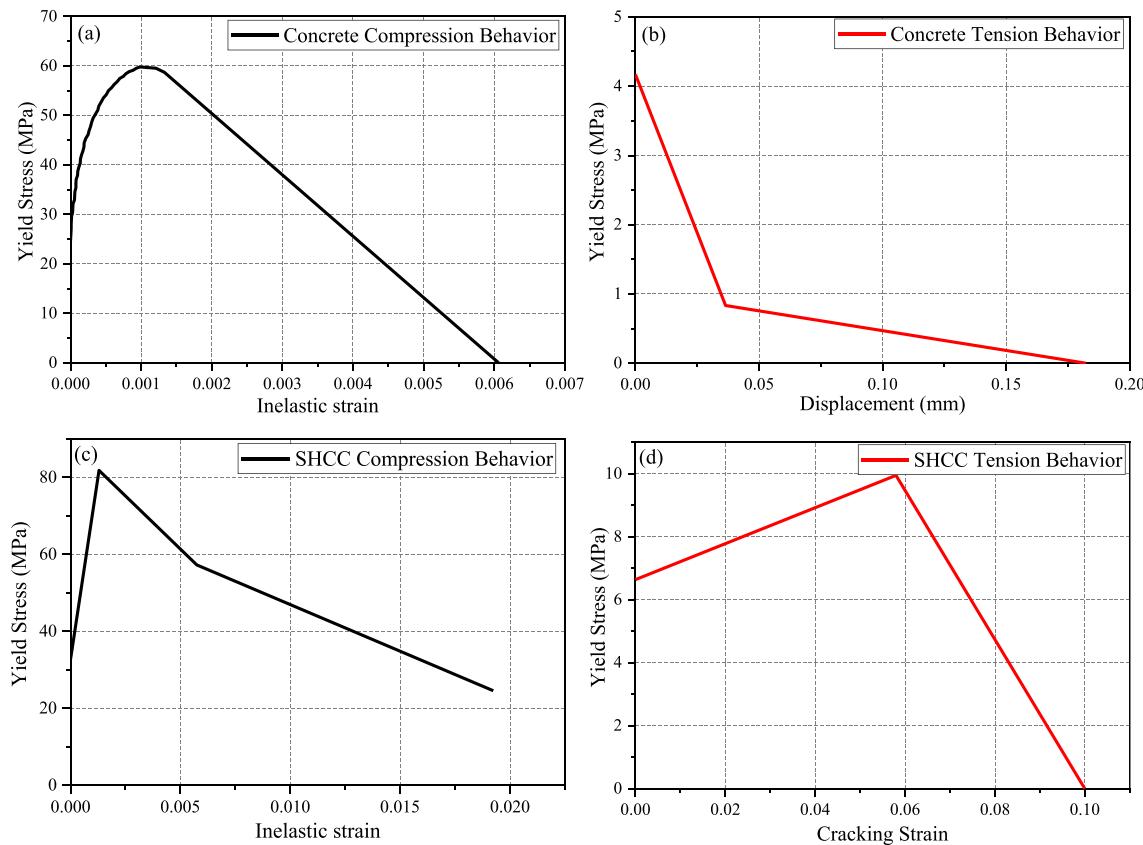
Fig. 10. Constitutive model curves: (a-b) for Concrete and (c-d) for high-strength SHCC.

tension phases. Within the CDP model, stress-strain curves for concrete under both compressive and tensile states are defined by the user. Specifically, the tensile stress-strain relationship is modeled as linearly elastic up to the point of cracking, followed by a bi-linear post-peak response. To simplify the simulation, damage variables in both tension and compression were omitted, as they have negligible impact on the structural response under monotonic loading conditions. Although ABAQUS does not provide a specific material model for SHCC, the CDP model's versatility allows for the simulation of SHCC by incorporating its distinctive tensile strain-hardening behavior observed prior to softening post-ultimate strength. This adaptability of the CDP model makes it suitable for simulating both traditional concrete and innovative materials like SHCC, thereby offering a comprehensive tool for analyzing the behavior of reinforced concrete structures under a variety of

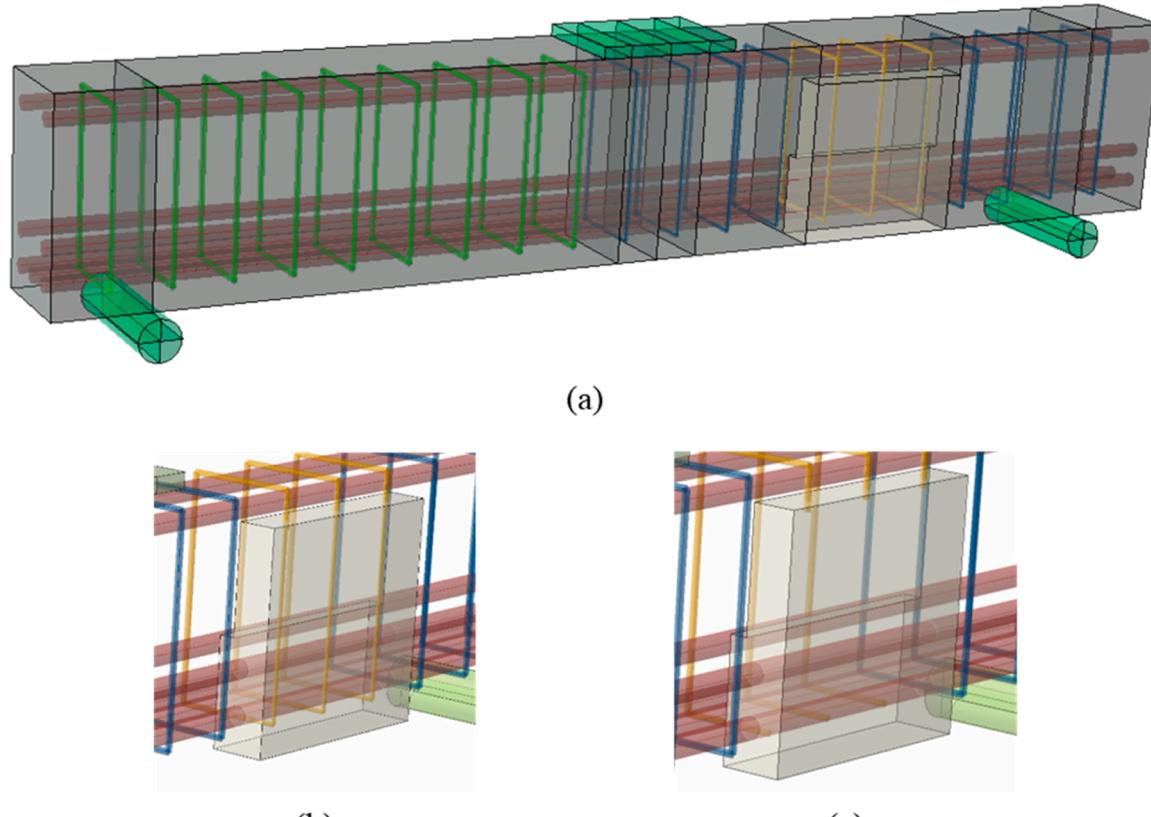
Fig. 11. Finite element model of the reinforced concrete beam with patch; (a) RC + high-strength SHCC model, (b) high-strength SHCC with 50 % reduced stirrup area, and (c) high-strength SHCC with 100 % reduced stirrup area.

The modeling of the concrete beam and high-strength SHCC patch utilizes eight-node brick elements (C3D8R), equipped with reduced integration to enhance computational efficiency. The steel reinforcement framework, encompassing both the longitudinal rebars and shear stirrups, is accurately represented through linear 3D truss elements employing a two-node system (T3D2). Upon assembling the various elements, the constraint module is engaged to seamlessly integrate the steel reinforcement within the concrete model, effectively designating the concrete as the host element. To accurately simulate the physical setup, loading plates and supports are constructed using an elastic

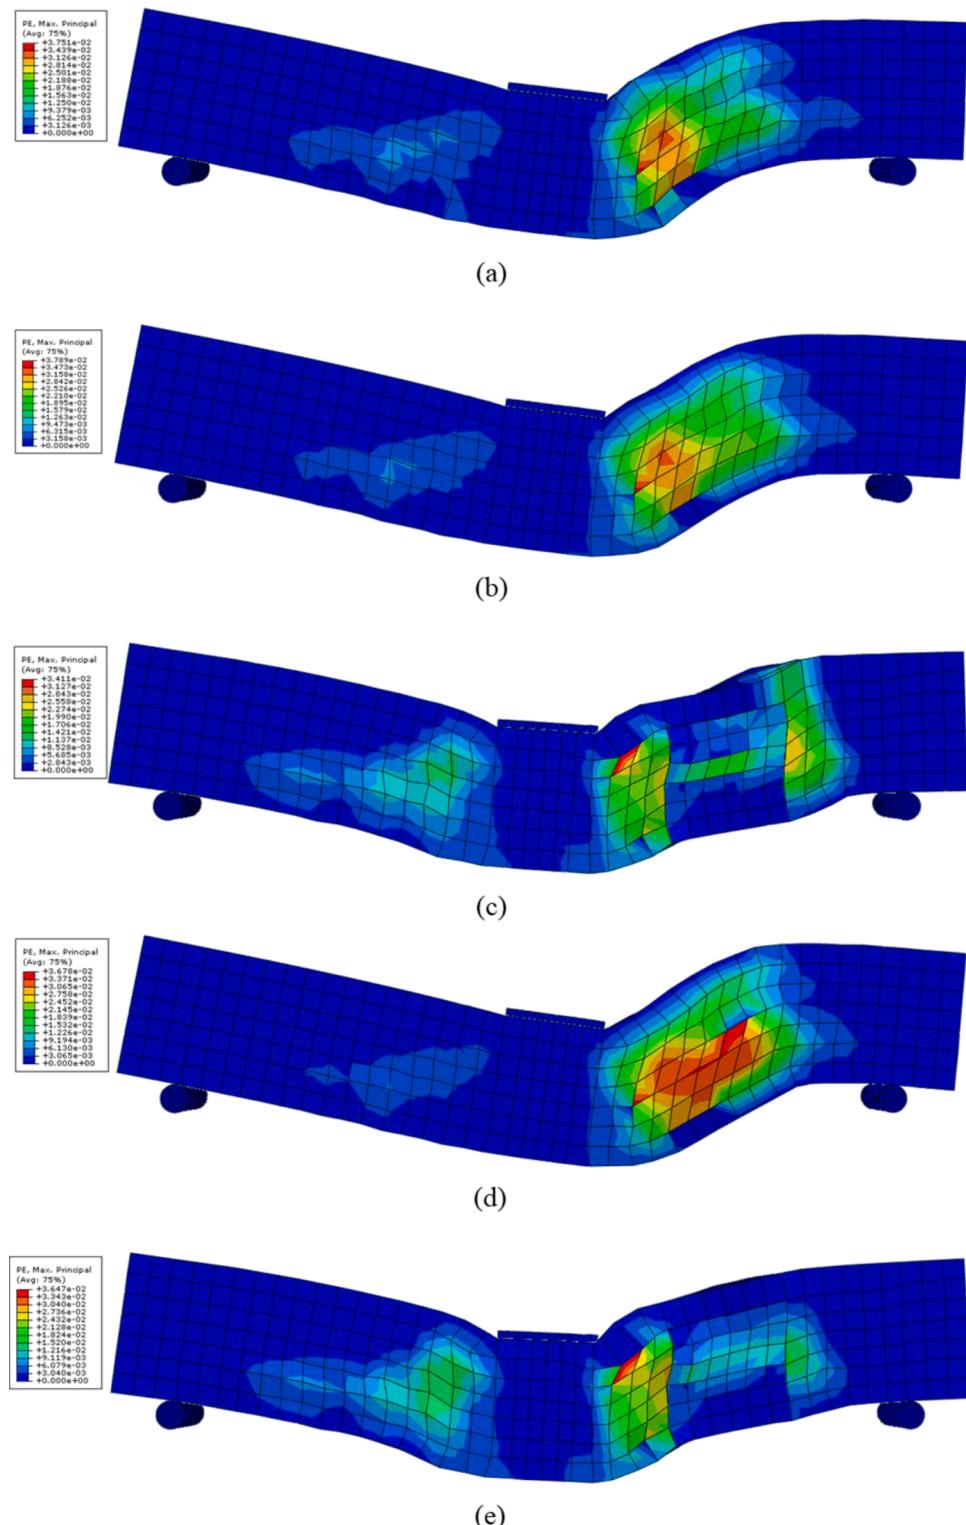
Fig. 12. Deformed shape of models: (a) REF-F(Model), (b) REF-R50(Model), (c) BP-50(Model), (d) REF-R100(Model), and (e) BP-100(Model).

Fig. 12 illustrates the failure modes of simulated models across all five examined cases, highlighting areas of higher stress and larger deformation, particularly on the right-hand side where stirrups are smaller (which may even be corroded). These simulations align with experimental observations, predicting failure predominantly on the beam's weaker side. Intriguingly, both experimental and simulation

results indicate that beam specimens BP-50 and BP-100, despite varying degrees of stirrup corrosion and being reinforced with identical high-strength SHCC patches, exhibit comparable load-bearing capacities up to the point of failure. To delve deeper into this phenomenon, Fig. 13 and Fig. 14 display the stress distribution within steel reinforcements and the high-strength SHCC patch across different loading stages (200 kN, 300 kN, 400 kN, ultimate load, and at the point of failure) for the BP-50 and BP-100 models, respectively.

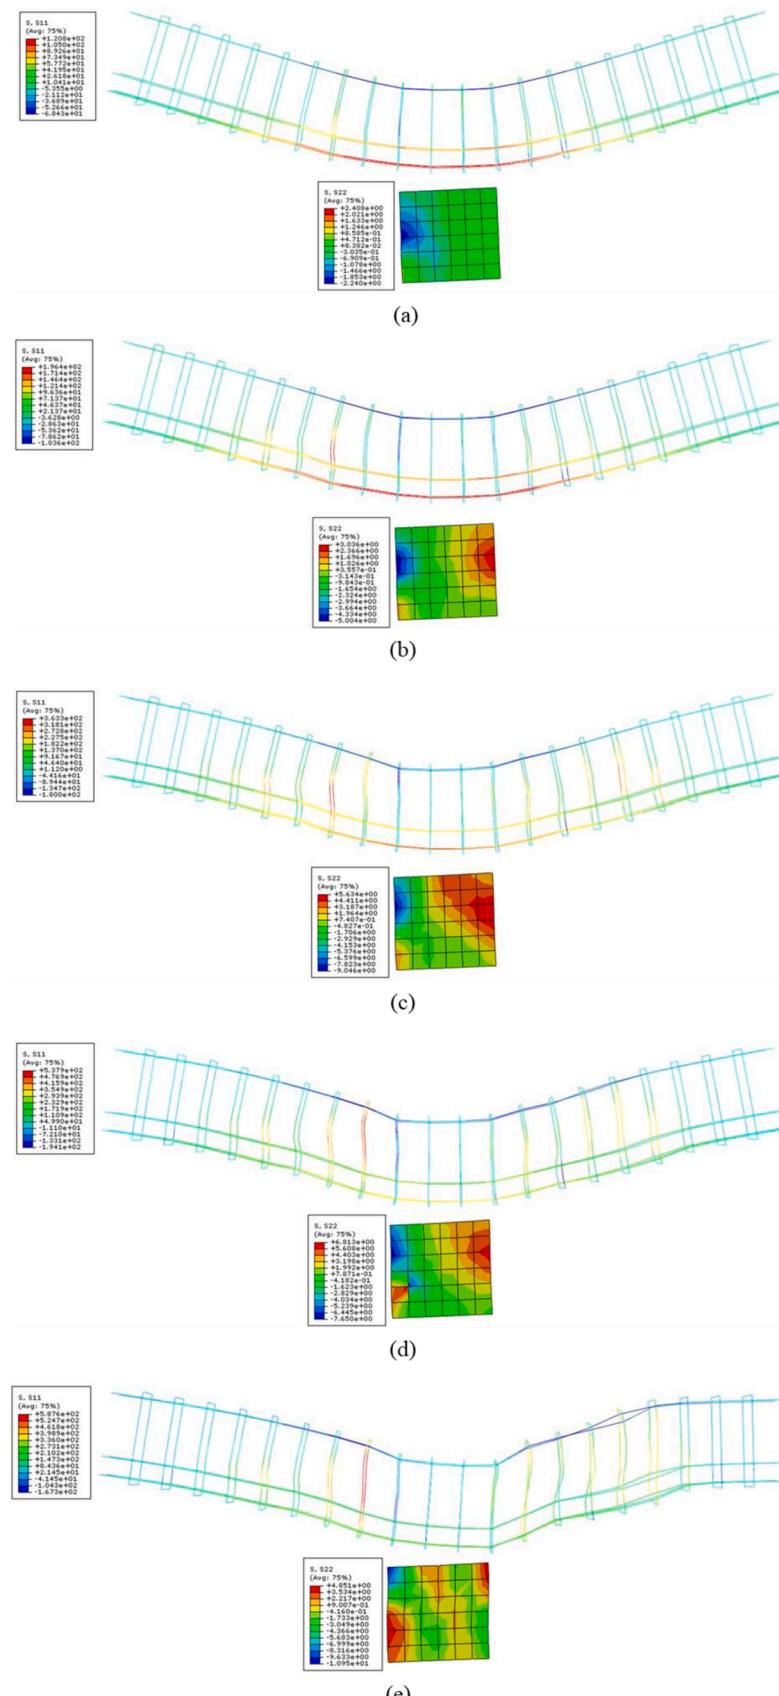
Fig. 13. Stress distribution in steel reinforcements and high-strength SHCC patch at different load levels for BP-50(Model): (a) 200 kN, (b) 300 kN, (c) 400 kN, (d) at ultimate load, and (e) at failure; color bar indicates vertical stress distribution, with abrupt color changes highlighting localized stress concentrations.

In the analysis of the high-strength SHCC patch, the vertical stress component, which acts in opposition to the shear force, is visualized using color contours. These stress plots demonstrate a progressive pattern of high stress initiation on the right-hand side of the patch, extending towards the left as the load increases from (a) to (d). Notably, the upper right-hand corner of the patch bears the highest vertical stress. This pattern aligns with experimental findings, where the predominant shear crack in the concrete traverses through the SHCC patch in this

specific area. **Fig. 13(d)** and **Fig. 14(d)** showcase the stress distribution at ultimate load for the BP-50 and BP-100 specimens, respectively. In these figures, areas depicted in yellow (and any hues representing values above this threshold) indicate stresses surpassing 1.992 MPa for BP-50 and 2.348 MPa for BP-100. A comparative analysis of these visuals reveals that a more substantial portion of the SHCC patch in BP-100 is subjected to high vertical stress. This observation sheds light on the comparable ultimate load capacities of BP-50 and BP-100, despite the latter experiencing complete corrosion of shear stirrups within the patched region. The FEM assumed a perfect bond between the SHCC patch and the substrate concrete, as described in the methodology. However, experimental results showed evidence of debonding at the interface under high loading conditions, particularly in specimens BP-100, as shown in **Fig. 9(g)**. This debonding could affect the stress transfer efficiency and load redistribution within the repaired beams. While the perfect bond assumption provides an optimistic scenario for modeling, incorporating a more realistic representation of the interface, such as cohesive zone models or contact elements, could better capture the influence of debonding on structural performance. Future studies should consider these approaches to further refine the numerical model and explore the effects of an imperfect bond on stress distribution and failure mechanisms.
