Effective restoration of reinforced concrete beams with severe stirrup corrosion using high-strength strain-hardening cementitious composites (SHCC)

ABSTRACT

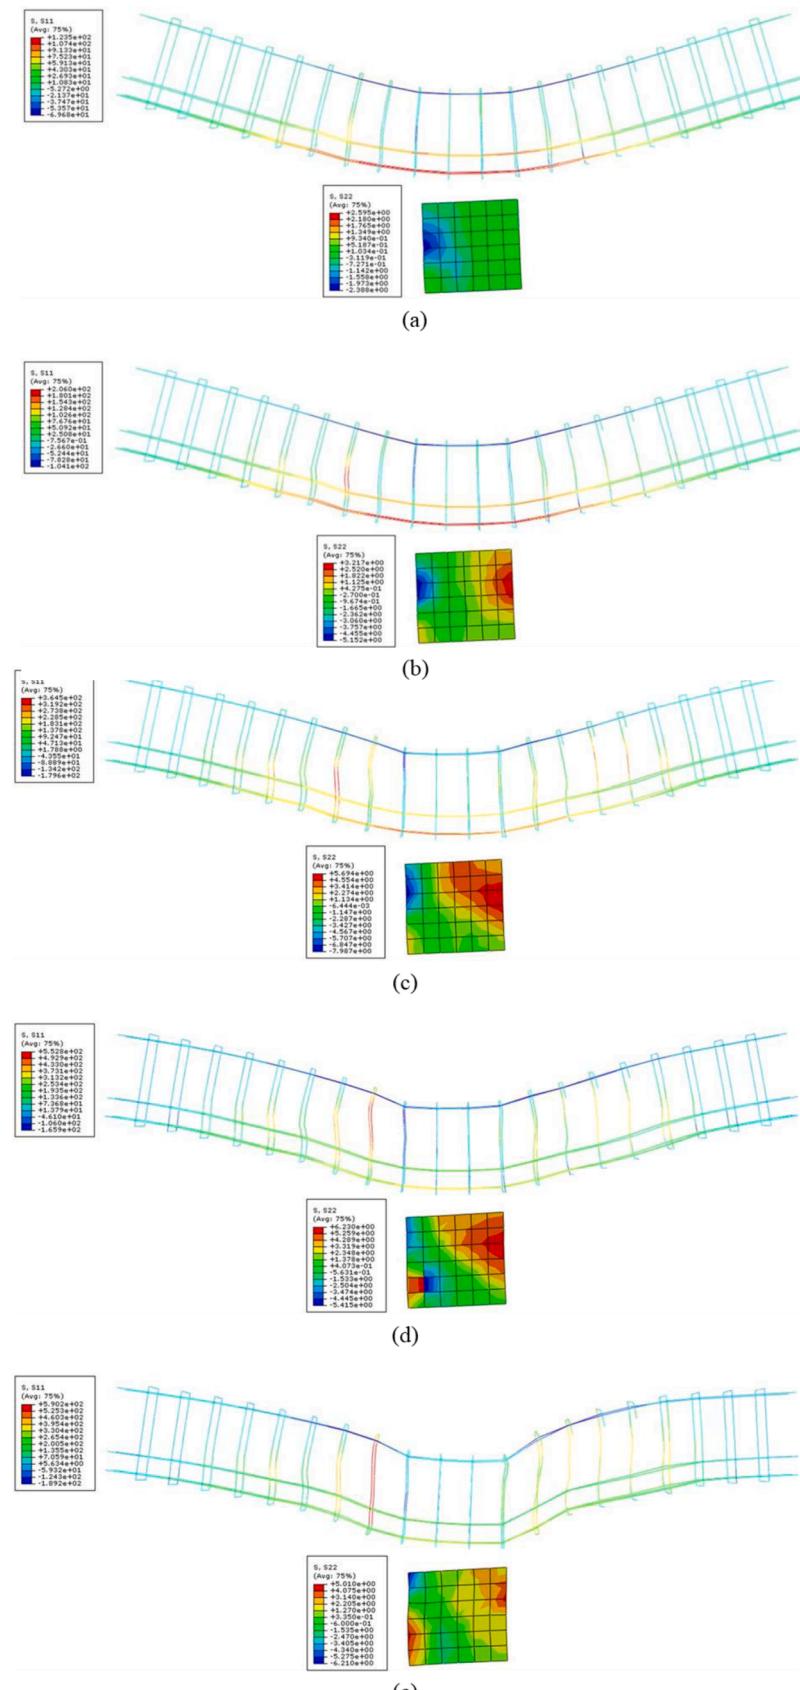
Fig. 14. Stress distribution in steel reinforcements and high-strength SHCC patch at different load levels for BP-100(Model): (a) 200 kN, (b) 300 kN, (c) 400 kN, (d) at ultimate load, and (e) at failure; colors represent stress magnitude, abrupt transitions indicate stress concentrations rather than discontinuous displacements.

specific area. **Fig. 13(d)** and **Fig. 14(d)** showcase the stress distribution at ultimate load for the BP-50 and BP-100 specimens, respectively. In these figures, areas depicted in yellow (and any hues representing values above this threshold) indicate stresses surpassing 1.992 MPa for BP-50 and 2.348 MPa for BP-100. A comparative analysis of these visuals reveals that a more substantial portion of the SHCC patch in BP-100 is subjected to high vertical stress. This observation sheds light on the comparable ultimate load capacities of BP-50 and BP-100, despite the latter experiencing complete corrosion of shear stirrups within the patched region. The FEM assumed a perfect bond between the SHCC patch and the substrate concrete, as described in the methodology. However, experimental results showed evidence of debonding at the interface under high loading conditions, particularly in specimens BP-100, as shown in **Fig. 9(g)**. This debonding could affect the stress transfer efficiency and load redistribution within the repaired beams. While the perfect bond assumption provides an optimistic scenario for modeling, incorporating a more realistic representation of the interface, such as cohesive zone models or contact elements, could better capture the influence of debonding on structural performance. Future studies should consider these approaches to further refine the numerical model and explore the effects of an imperfect bond on stress distribution and failure mechanisms.
