Shake-table tests of large-scale shear wall and infilled frame models

A. K. H. Kwan BSc(Eng), PhD, MICE and J. Q. Xia BSc(Eng), PhD

- In order to evaluate and compare the seismic performance of different types of wall construction, three 1/3 scale four-storey models of structural walls were tested dynamically to ultimate failure by subjecting each of them to a sequence of simulated earthquakes of progressively increasing magnitude on a 5 m × 5 m shaking table. The three models tested are respectively: a reinforced concrete shear wall structure; a masonry infilled reinforced-concrete frame structure; and a concrete infilled steel frame structure. They have the same overall dimensions and were designed to represent typical wall constructions. Before and at intervals during the shake-table tests, the models were also subjected to small amplitude vibration tests to measure their dynamic properties and the corresponding changes as the structures degraded. From the shake table and small amplitude vibration tests, the seismic behaviour, damage characteristics, structural degradations and dynamic shear strengths, etc., of the models are studied and compared. Two problems with the structu

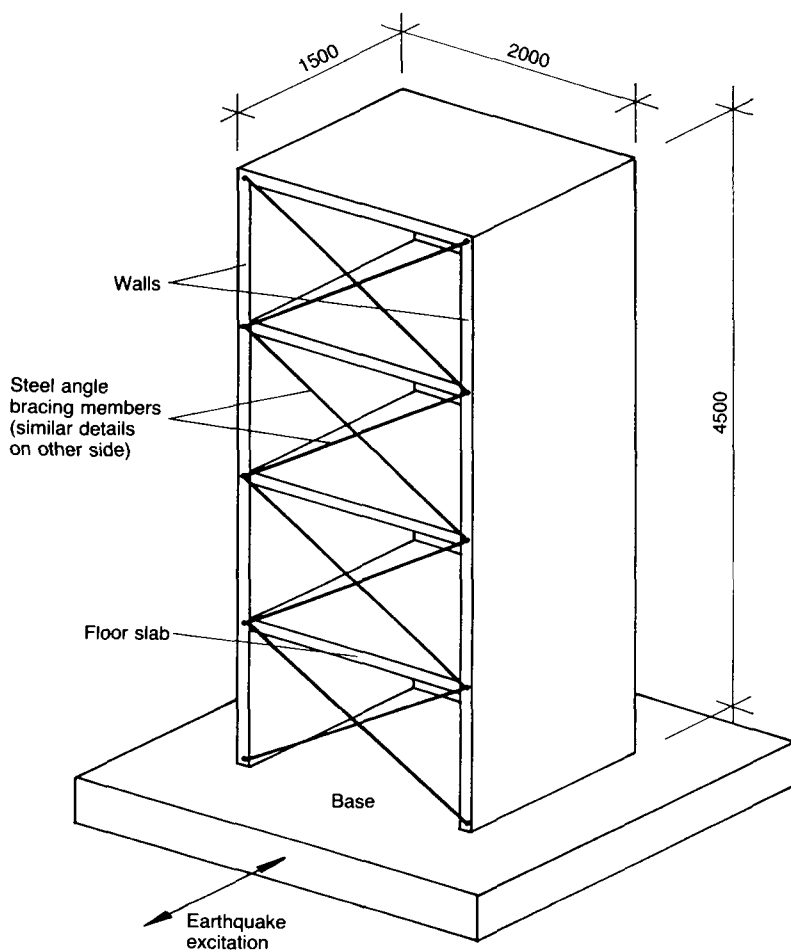
Fig. 1. General layout of models (all dimensions in mm)

15. In Fig. 1, the general layout of the three models tested is shown. The structural parameters were chosen so that the models resemble typical portions of four-storey buildings at 1/3 reduced scale. Each model consisted of a pair of identical and parallel walls interconnected at the floor levels by concrete slabs. The three models tested are

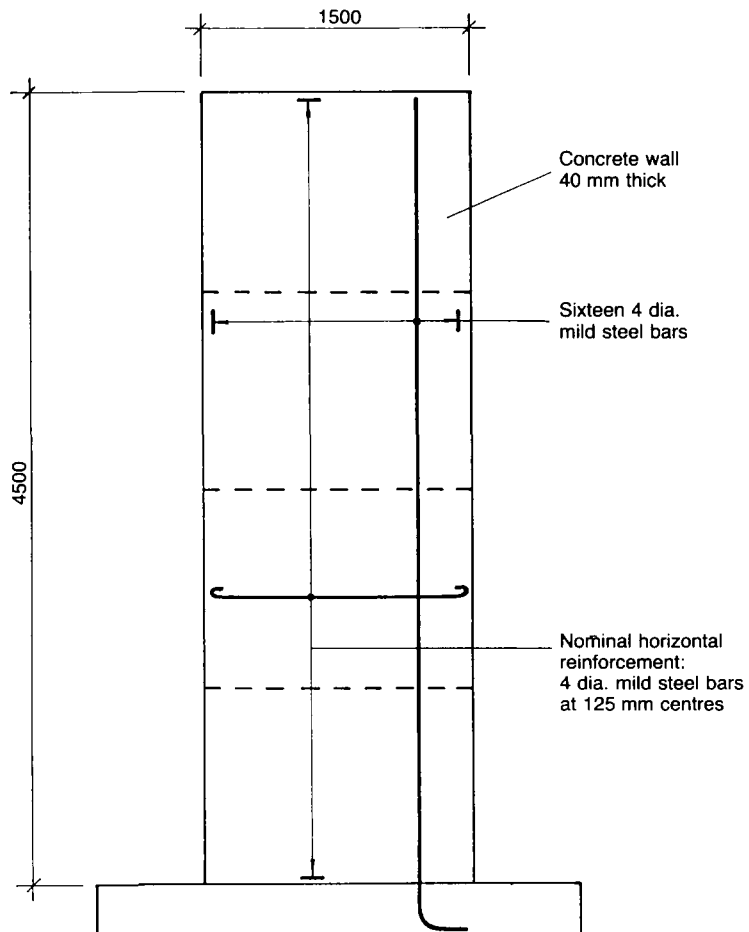
16. The shear walls of model 1, details of which are shown in Fig. 2, were cast of 40 mm thick concrete. Each wall was provided with vertical reinforcement consisting of sixteen 4 mm diameter mild steel bars evenly distributed in the wall section, and nominal horizontal reinforcement consisting of 4 mm diameter mild steel bars at a vertical spacing of 125 mm centres. Generous anchorage for the vertical reinforcement was provided by extending the reinforcement bars deep into the base. The walls were cast vertically storey by storey together with the floor slabs as in actual site construction. Material tests revealed that the cube strength of the concrete at the time of model testing was 10.2 MPa and the yield strength of the mild steel reinforcement was 238 MPa.

Fig. 2. Model 1: reinforced concrete shear walls (all dimensions in mm)

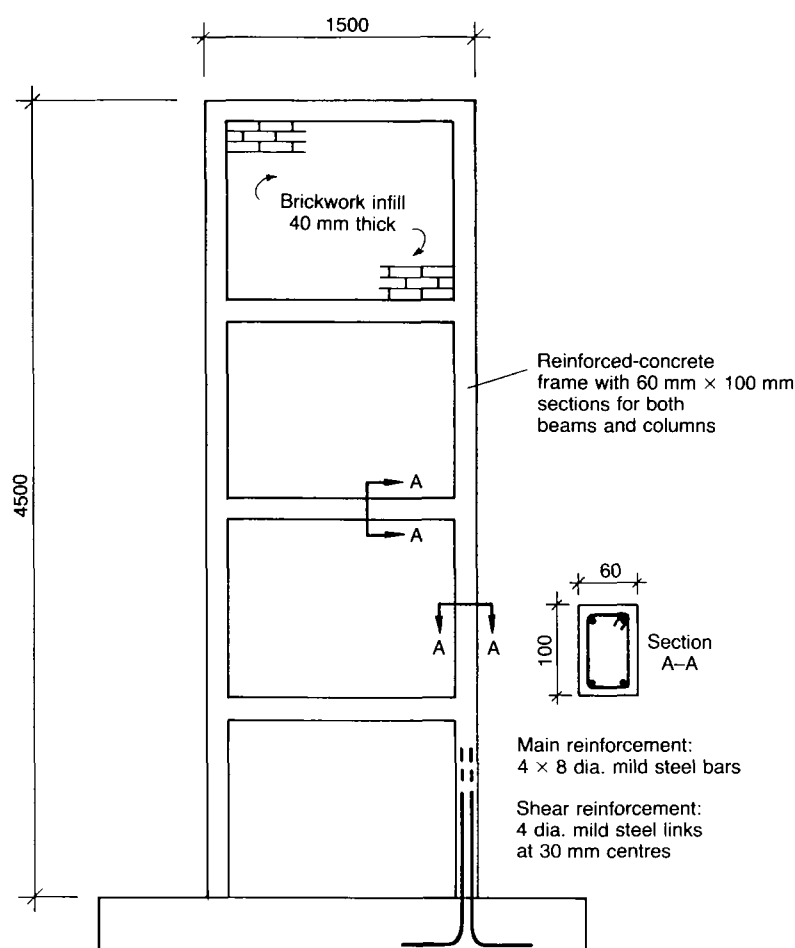
17. The infilled frames of model 2 (Fig. 3) were constructed of reinforced concrete frames and brickwork infills. Both the beams and columns of the frames have the same section of 60 mm × 100 mm and the same reinforcement details. The longitudinal reinforcement consisted of four 8 mm diameter mild steel bars, while the transverse reinforcement consisted of 4 mm diameter mild steel stirrups at 30 mm centre-to-centre spacing. As for the previous model, generous anchorage for the longitudinal reinforcement of the columns was provided by extending the reinforcement bars deep into the base. The frames were cast in situ storey by storey together with the floor slabs. Concrete cube strength at the time of model testing was 12.5 MPa. Yield strength of the mild steel reinforcement bars was 238 MPa. The brickwork for the infills consisted of model clay bricks with a dimension of 19 mm × 39 mm × 80 mm. Typical mortar joint thickness was about 2 mm. The brick units have a compressive strength of 13.7 MPa, and the mortar used for the joints has a compressive strength of 2.2 MPa. No connectors were provided to bond together the brickwork panels and the frames. As such, this model is a non-integral infilled frame structure.

Fig. 3. Model 2:
brickwork infilled
reinforced concrete
frames (all
dimensions in mm)

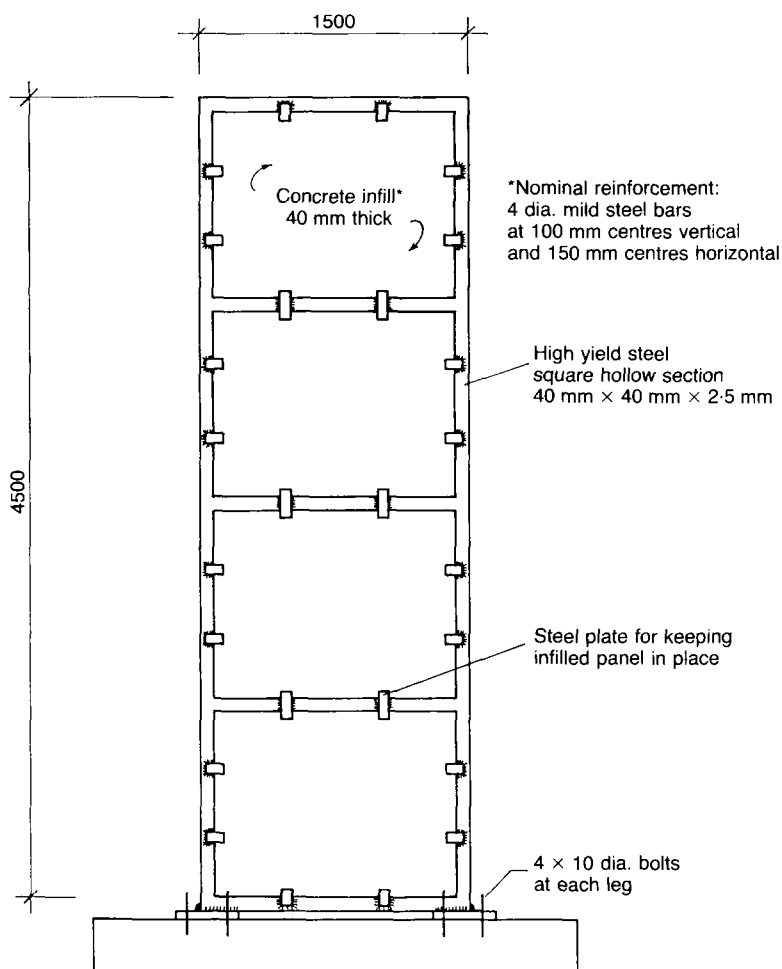
18. The infilled frames of model 3 (Fig. 4) were constructed by infilling steel frames with concrete panels. Both the beam and column members of the frames were made of 40 mm × 40 mm × 2.5 mm thick high yield steel square hollow sections. Originally, the frame members were designed as mild steel sections so that the static strength of the model would be similar to those of the other models, but owing to unavailability of suitable mild steel sections, high yield steel sections were finally used. Welding was used to join together the frame members, and the complete frame structure was connected to the base by four strong fixing bolts at each leg. The infilled concrete panels were 40 mm thick and contained nominal reinforcement,

Fig. 4. Model 3:
concrete infilled steel
frames (all
dimensions in mm)

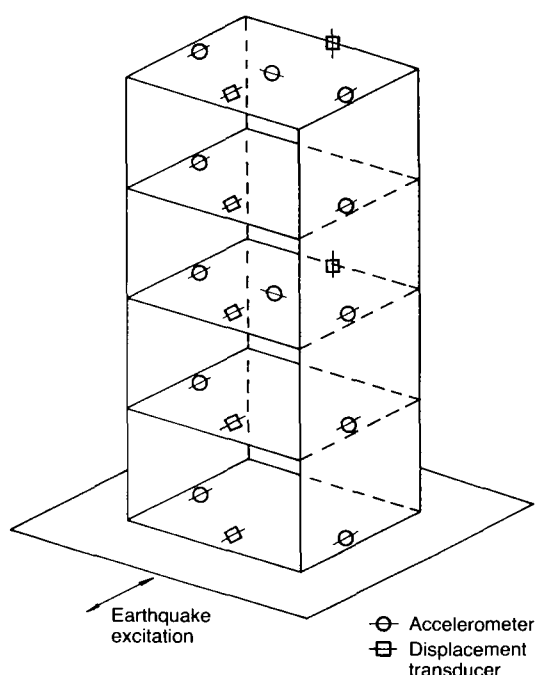
Fig. 5. Arrangement of accelerometers and displacement transducers

24. The horizontal acceleration and displacement responses of the models in the longitudinal direction (the direction parallel to the planes of the walls) were measured by two accelerometers and one displacement transducer on each storey. The accelerometers were located on the floor slabs adjacent to the walls while the displacement transducers were located at the centres of the floor slabs. In contrast, the transverse responses were measured by one accelerometer on the second floor and another on the fourth floor, which were both oriented perpendicular to the walls. In addition, vertical displacement transducers were also installed on the second and fourth floors. In Fig. 5 the overall arrangement of the accelerometers and the displacement transducers is shown. With regard to strain measurements, in model 1, strain gauges were installed on to the steel reinforcement bars at the wall-base junction. In model 2, the strain gauges were installed on to the vertical reinforcement in the columns of the lowest storey; while in model 3, the strain gauges were glued on to the surface of the steel column members at the lowest storey. Some other strain gauges were also fixed on to the concrete and masonry surfaces at the lowest storey. All the transducer signals were logged by microprocessor controlled data-loggers and were recorded on magnetic tapes for later data processing.

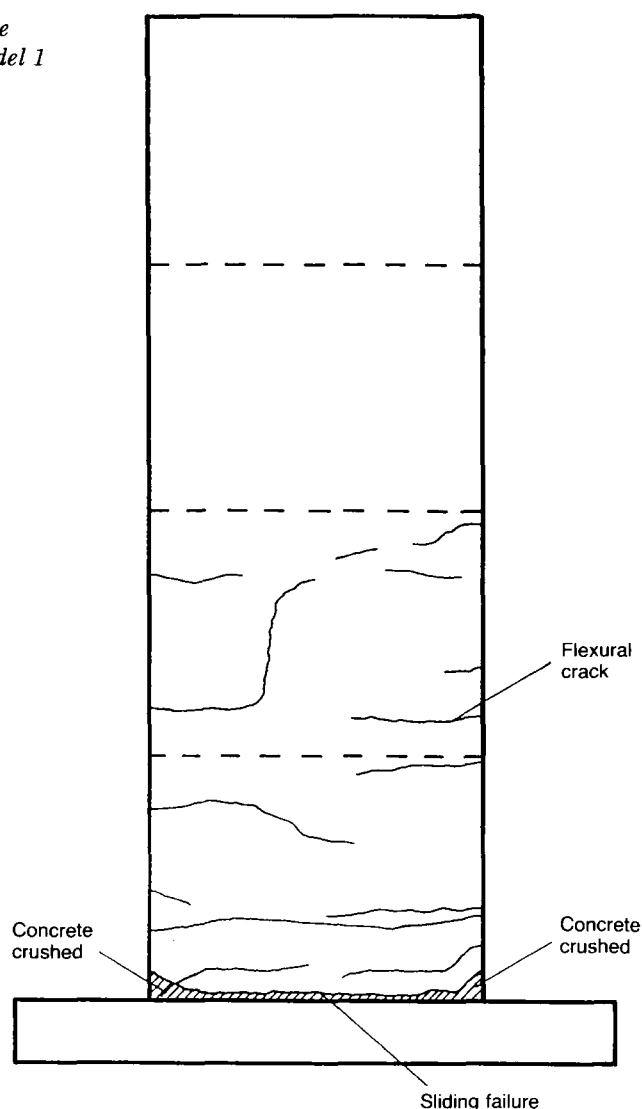
25. Basically, the shear walls acted like vertical cantilevered beams during the earthquake tests. The walls started to crack at the corners of the lower two storeys when the peak acceleration of the applied earthquake reached 0.38 g . As simulated earthquakes of progressively larger peak acceleration were applied, the previously formed cracks gradually extended horizontally towards the centroidal axis of the walls and more horizontal cracks appeared. When the peak acceleration reached 0.75 g , the cracks developed to such an extent that horizontal cracks cutting through the whole width of the walls were formed near the wall-base junctions. However, the structure continued to withstand even stronger earthquakes. After an earthquake with a peak acceleration of 0.83 g was applied, signs of concrete crushing and steel yielding at the roots of the walls were obvious. At the lowest corners of the walls, the concrete was so severely crushed that the reinforcement bars there were exposed. It could be seen that the vertical rebars at the roots of the walls had been shifted laterally because of dowel action and sliding of the walls relative to the base. Some of the vertical rebars there, particularly those near the edges of the walls, had even buckled. Although the structure had been seriously damaged after the 0.83 g peak acceleration earthquake test, it had not collapsed. In order to ascertain whether or not the structure could withstand a larger earthquake, the peak acceleration was increased further to 0.95 g . After the 0.95 g earthquake, the model remained standing, although it was very badly damaged. The earthquake test was then ended. Inspection of the shear wall structure after completion of the earthquake tests revealed that the shear walls were badly damaged by shearing at the wall-base junctions. This sliding shear failure mode was quite different from the failure by bending that was observed during the static load test. Hence the failure mode of shear walls may be different under seismic load than under static load. In Fig. 6, the failure pattern of the model is shown.

Fig. 6. Failure pattern of model 1

35. Shear walls, on the other hand, are not without problems. As observed from the earthquake tests, model 1 failed under the earthquake loads by sliding along the wall-base joints rather than by flexure, as would have been expected from the results of the static load tests. The shear walls of model 1 have a height to width ratio of 3.0 and should therefore be regarded as tall shear walls.^{6,7} The occurrence of sliding shear failure in such a tall shear wall structure reveals the fact that sliding shear failure can occur not only in squat shear walls but also in taller shear walls. More care in designing for the sliding shear resistance of shear walls is required. This phenomenon of substantial reduction in sliding shear strength during earthquakes had, in fact, been recognized by Paulay⁶ early in the 1960s. Based partly on Paulay's study and partly on the observations made in the present shake-table tests, an explanation for the above phenomenon is given as follows. Initially, the shear walls behaved as vertical cantilevered beams. The bending moments acting on the walls during the earthquakes caused flexural cracks to be formed at both sides of the walls. As the earthquake loads increased, the flexural cracks gradually extended towards the centroidal axis of the walls until eventually some of the cracks cut through the whole width of the walls. Following a further increase in loading, the alternate near ultimate loading caused the vertical reinforcement to yield. Excursion of the vertical reinforcement into the post-elastic range led to considerable residual strains in the reinforcement and, consequently, to widening of the cracks in the surrounding concrete. As a result, on load reversal, the cracks did not close immediately. Before the cracks closed, the vertical reinforcement carried most of the vertical compression, thereby leading to possible compression yielding or buckling of the reinforcement bars. More importantly, the compression in the

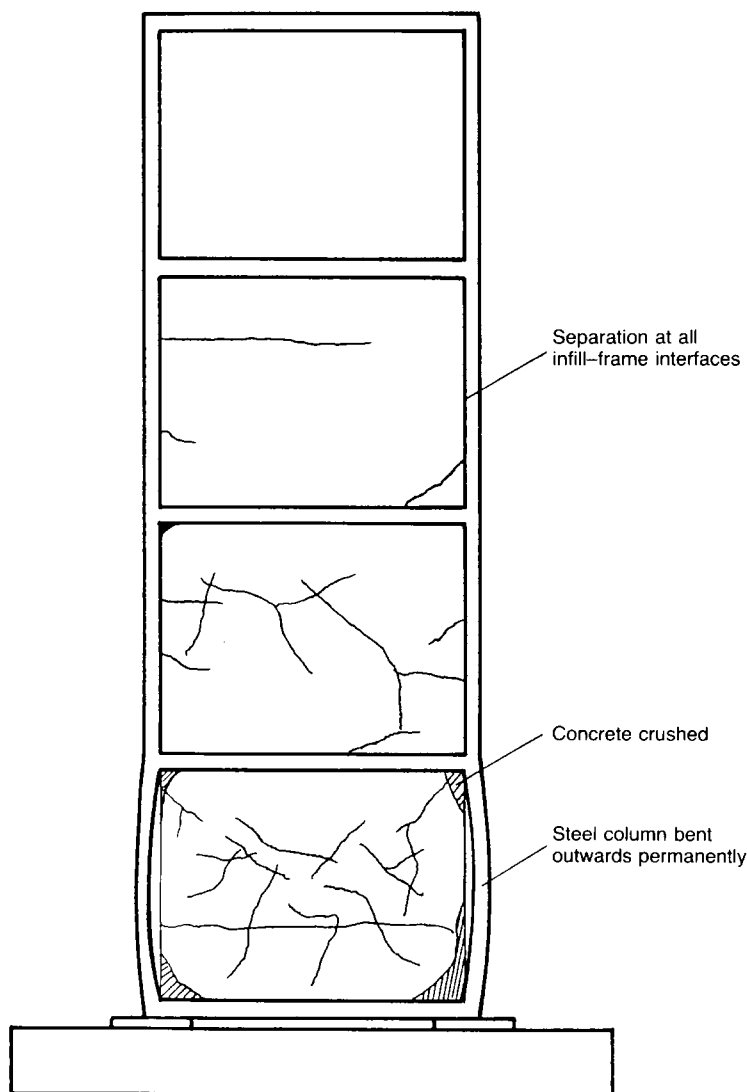
27. Since the concrete infilled panels and the steel frames were not connected by any means, the infilled panels started to separate from the bounding frames during the first earthquake test when the peak acceleration applied was only 0.20 g. After the separation, the panels acted as diagonal struts, bracing the skeletal frame structure. When the peak acceleration reached 0.48 g, some fine inclined cracks began to appear on the infilled panels at the first and second storeys. At the same time, the gaps between the infilled panels and the frame members widened. When the peak acceleration reached 0.70 g, the previously formed cracks on the panels widened and more new diagonal cracks were formed. After a peak acceleration of 0.77 g was applied, the lower corners of the infilled panels at the first storey were crushed locally, leaving even wider gaps between the panel corners and the frames. However, the structure still worked as a composite structure, with the concrete panels acting as diagonal struts. When the peak acceleration was increased further to 0.94 g, all corners of the first storey concrete panels were crushed. Moreover, the column members in the first storey were bent permanently outwards, indicating the formation of plastic hinges at the ends of the columns. Some fine cracks also started to appear on the infilled panels at the third storey. When the peak acceleration reached 1.18 g, the previously formed cracks widened, more cracks appeared, all corners of the infilled panels in the first storey were very badly damaged and the permanent deformations of the first storey columns became very large, but the integrity of the structure still remained good. At this stage, the corners of the infilled panels on the second storey also started to crush. Furthermore, it was observed that the infilled panels in the lowest storey were rocking against the columns of the bounding frames during the earthquake test. In order to investigate how much more peak acceleration the structure could withstand, the peak acceleration was increased further to 1.27 g and then to 1.50 g. After these two earthquakes were applied, the structure was very badly damaged, but it did not collapse. It appeared during these two earthquake tests that the infilled panels at the first storey had lost the bracing capability and, as a result, the lowest storey had become a soft storey, thereby isolating the structure from the base motions. The earthquake test was then stopped. In Fig. 8, the failure pattern of the model is shown.

Fig. 8. Failure pattern of model 3

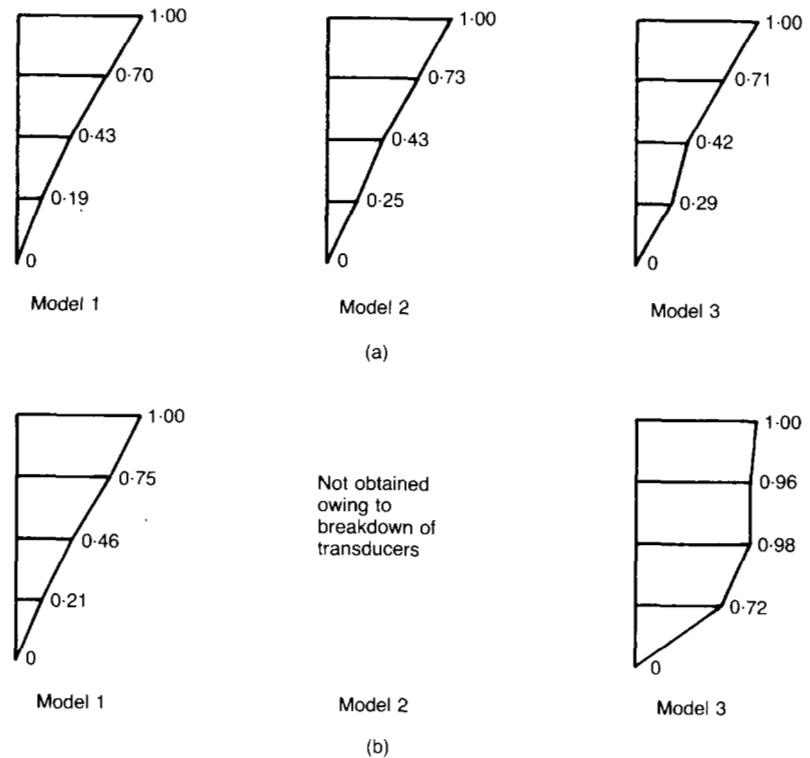
30. The mode shapes of the three models corresponding to the first vibration mode in the in-plane direction of the walls as measured by the small amplitude vibration tests are plotted in Fig. 9. From the results of model 1, it can be seen that the vibration modes of model 1 at the initial and failure states are generally curve-shaped, and that the maximum curvatures occur at the roots of the walls. Such curvatures, which were the results of flexural deformations, indicate that the shear walls acted like vertical

cantilevered beams, deflecting in both shear and flexure during the vibrations. Comparing the mode shapes at different states, it can also be seen that even when the shear wall structure approached the failure state, there was very little change in its vibration mode shape. The only noticeable change in the mode shape as the structure degraded was the slight increase in shear and bending deformations at the lower parts of the walls compared with those at the initial state. This was the result of the more rapid degradation near the roots of the walls. With regard to the mode shape results of the other two models, it can be seen from Fig. 9 that the mode shapes of both models 2 and 3 were quite linear at the initial state. The small curvatures of the mode shapes reveal that the flexural deflections were insignificant and that the two models acted like shear structures. Owing to a break-down of the transducers, the mode shape of model 2 at the failure state was not obtained. Nevertheless, from that of model 3, it can be seen that as the infilled frame structure degraded, its mode shape changed quite significantly, the shear deflection of the first storey increasing at a faster rate than those of the upper storeys until, at the failure state, the shear deflection of the first storey was much larger than those of the upper storeys. Although the mode shape of model 2 was not obtained, the other observations suggested that its mode shape at the failure state was similar to that of model 3. Hence it may be concluded that for the two infilled frame models tested, the stiffness of the lowest storey degraded much more rapidly than the upper storeys. It was the rapid degradation of the lowest storey which led to the large reduction in natural frequencies towards the failure state.

Fig. 9. Shape of first vibration mode in in-plane direction of walls: (a) at initial state; (b) at failure state

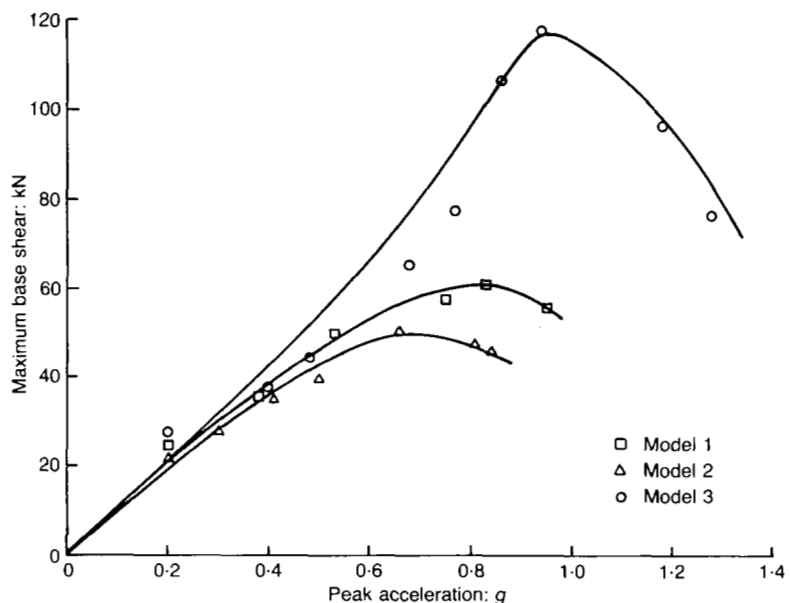
Fig. 10 shows the maximum base shear so evaluated for each model plotted against the peak acceleration of the applied earthquake.

shear induced during a simulated earthquake increased with the peak acceleration of the applied earthquake motions until a certain peak value of maximum base shear was reached; thereafter, the maximum base shear started decreasing, indicating that the model structure had then been very badly damaged and could take only an ever decreasing shear load when subjected to further earthquake excitations. From the results shown in Fig. 10, the following can be seen: in model 1, the maximum base shear reached a peak value of 59.8 kN at a peak acceleration of 0.83 g; in model 2, the maximum base shear reached a peak value of 50.5 kN at a peak acceleration of 0.66 g; in model 3, the maximum base shear reached a peak value of 116.4 kN at a peak acceleration of 0.94 g.

Fig. 10. Variation of maximum base shear with peak acceleration of applied earthquake

33. The state when the maximum base shear reached the peak value may be regarded as the ultimate limit state under earthquake attack because, beyond this state, the structure may be considered to have failed. Based on this philosophy, the peak value of maximum base shear reached at the ultimate limit state may be taken as the dynamic shear strength of the structure. The dynamic shear strengths of the models so defined are compared with the corresponding static shear strengths (measured by the static load tests carried out separately on the duplicate set of models) in Table 2. It is revealed that the ratios of dynamic shear strength to static shear strength were 0.82, 0.89 and 1.02 for models 1, 2 and 3 respectively. The ratio of dynamic shear strength to static shear strength was particularly low for model 1. This was on account of the fact that model 1 developed its full flexural strength under the static load case (it failed by flexure during the static load test), but was not capable of developing its full flexural strength during the earthquake tests because of sliding shear failure (it failed by sliding at the wall-base junctions during the earthquake tests). From this result, it may be concluded that the sliding shear strengths of shear walls can be significantly lower under dynamic/cyclic load than under static/monotonic load. For the other two models, the dynamic shear strengths were basically the same as the corresponding static shear strengths. The cumulative damage caused by the simulated earthquakes applied before the ultimate limit state was attained did not significantly reduce the shear strengths of the infilled frame models.
