Case Report

Restorative Management of Severe Localized Tooth Wear Using a Supraoccluding Appliance: A 5-Year Follow-Up

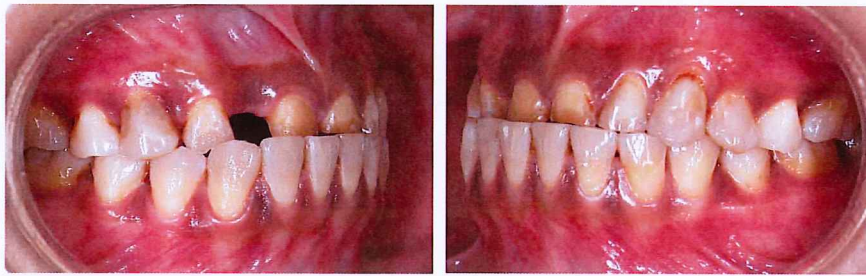
FIGURE 1: Preoperative lateral views with teeth in centric occlusion.

2.2. Clinical Findings. This patient presented with competent lips, average lip line, normal TMJ's, and class III incisor relation (Figure 1) on a skeletal class 3 base. The patient had good oral hygiene and a healthy periodontal condition. Tooth 13 was missing and 12 had drifted to the 13 position (Figure 2). There was severe erosive tooth surface loss on the palatal and incisal surfaces of teeth 11, 21, and 22 with exposure of dentine over the whole palatal surface. The crown height of the two upper central incisors was reduced to 5 mm. This gave rise to a reduced visible crown height and a reverse smile line (Figure 3). The gingival level of the upper central incisors was level with the lateral incisors and

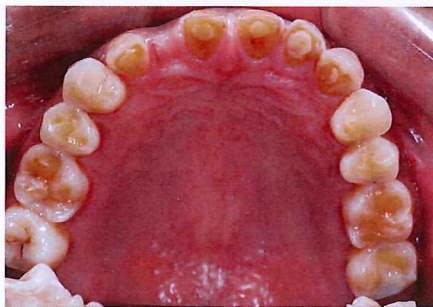
FIGURE 2: Preoperative upper occlusal view.

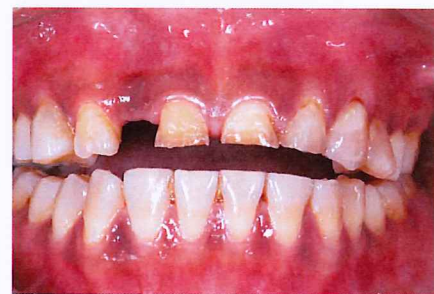
FIGURE 3: Preoperative frontal view with teeth apart.

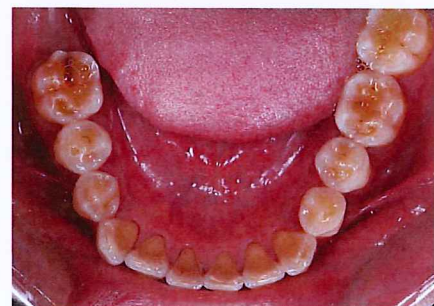
FIGURE 4: Preoperative lower occlusal view.

below that of the canine teeth. A crack line was detected at 46 distoocclusal area (Figure 4) with no periapical radiolucency (Figure 5), and a diagnosis of crack tooth syndrome was suspected. Teeth 12, 22, 23, and 46 were judged vital with the use of electric pulp testing.

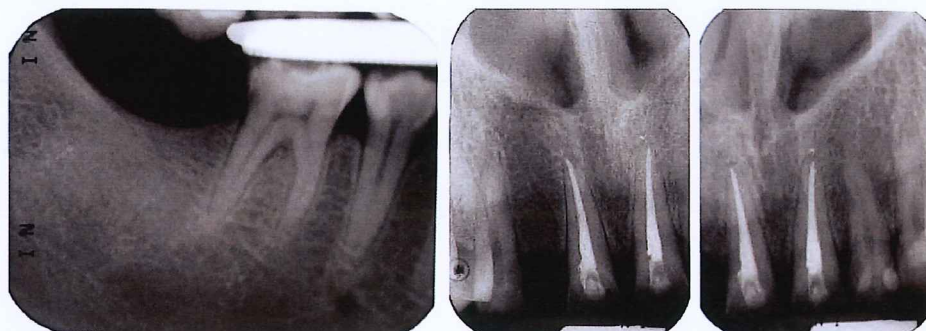
FIGURE 5: Preoperative periapical of 46 and upper anterior teeth showing no periapical radiolucency with good alveolar bone level.

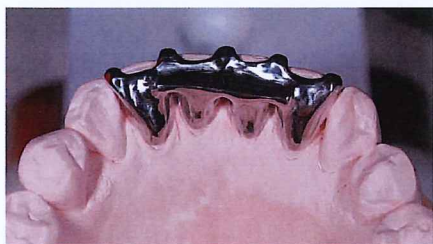
FIGURE 6: Lingual view of the bite platform on working model.

The supraoccluding appliance was waxed up on the lingual surface of the lower incisors with a bite platform designed to load the opposing incisor axially. Incisal hooks were included to give the appliance resistance form. This was then cast in cobalt-chromium (CoCr) (Remanium® GM 800+, DENTAURUM GmbH & Co., Ispringen, Germany) (Figure 6). The appliance was then cemented on lower incisors with glass ionomer cement (Ketac Cem, ESPE-Premier Sales Corp., Norristown, PA, USA). At the same visit, composite resin (Aeliteflo™, Bisco Inc., Schaumburg, IL, U.S.A) was directly added to restore the incisal edges of 11 and 21 and facilitate occlusion on the opposing bite platform

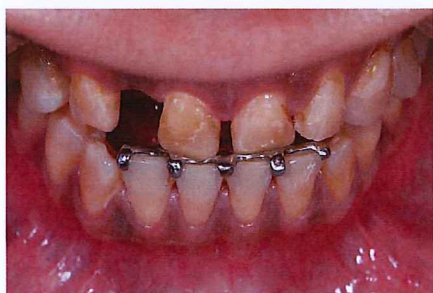
FIGURE 7: Stable occlusion of numbers 11 and 21 on the lingual bite platform.

at the increased OVD of 1.5 mm (Figures 7 and 8) using a silicone putty jaw record as a jig.

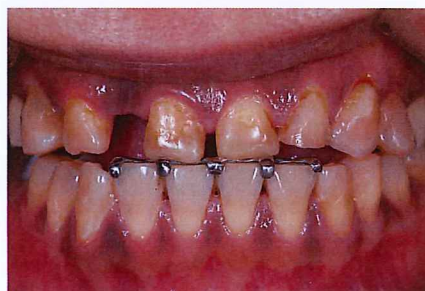
FIGURE 8: The appliance in situ with composite build-up in supraocclusion on numbers 11 and 21 incisal to separate all other teeth by 1.5 mm. The design of using incisal hooks on the lower teeth helps improve the resistance to dislodgement of the appliance.

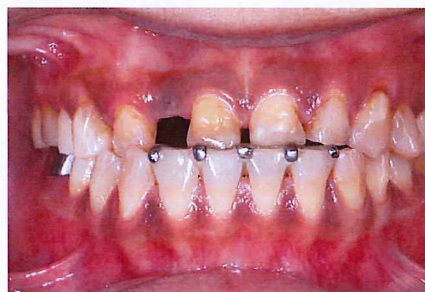
FIGURE 9: Complete reestablishment of the occlusal contacts 2 months after appliance cementation.

After 2 months, the posterior teeth were found to be in occlusion (Figure 9). At this time, further “intrusion” of the upper incisors was judged to be necessary if the incisal overjet was to be changed from reverse to positive. Therefore, further composite build-up was performed on the incisal edges of 11, 21, and 22 to again create supraoccluding restorations on the lower appliance (Figure 10). The OVD was raised by another

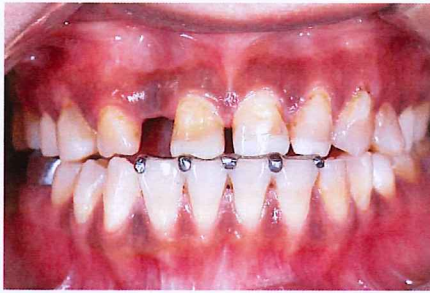
FIGURE 10: Further composite build-up on numbers 11, 21, and 22 incisal to separate all other teeth by 1.5 mm.

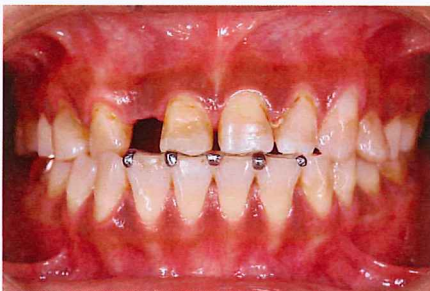
FIGURE 11: The occlusion reestablished full arch contacts over 9 months after appliance insertion, with crown heights of numbers 11 and 21 increased from 5 to 8 mm and number 22 from 5 to 7 mm.

1.5 mm which was measured between the midlabial gingival margins of 21 and 32. Complete reestablishment of all occlusal contacts was achieved after another seven months (Figure 11). Therefore, at this time, the lower supraoccluding appliance was removed by cutting off the incisal hooks and tapping off the prosthesis.

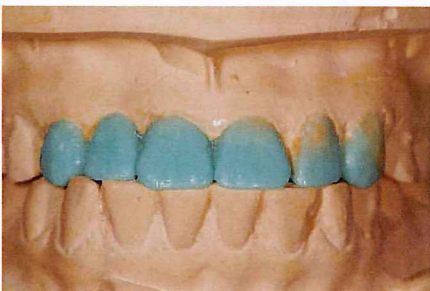
FIGURE 12: Diagnostic wax-up on number 13 to number 23 new study casts.

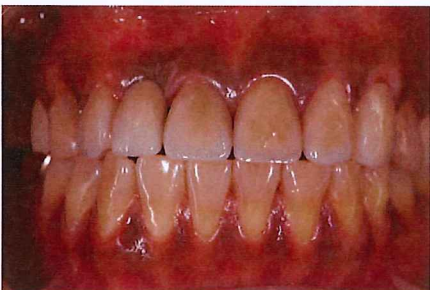
FIGURE 13: Temporary crowns in situ, which were designed to provide positive overjet. However, the crown height of numbers 11 and 21 looked short, and the tooth number 12 at 13 region did not look like a canine.

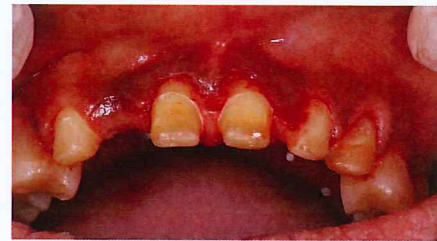
FIGURE 14: Surgical crown lengthening.

the expected final crown contour and margins. Surgical crown lengthening was performed (Figure 14) with alveolar bone being removed by approximately 1.5 mm limited to the midlabial of 12, 11, and 21. Tooth preparation margins were refined, and new temporary restorations using Prottemp were made chairside using an index of the diagnostic wax-up of the expected final restorations (Figure 15).

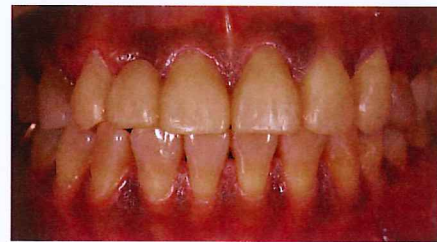
FIGURE 15: Temporary restorations numbers 13–23 in situ 1 month after crown lengthening on numbers 12, 11, and 21.

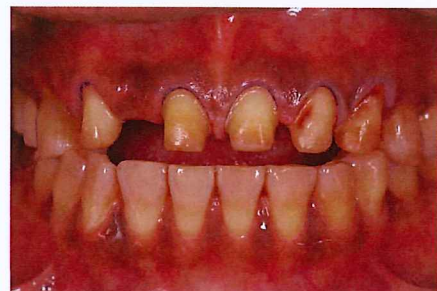
FIGURE 16: Tooth preparation on numbers 12 to 23.

The intrusion of the incisors now permitted the incisal edges to be positioned with a positive overjet and overbite. A period of six months was allowed for the healing and stabilization of the soft tissues, and the patient was satisfied with the aesthetics with diagnostic restorations following review after 6 months. The form and contour of these diagnostic restorations were recorded and copied in the final restorations. Definitive restorations were provided in Empress II (Ivoclar Vivadent, Amherst, NY, USA) and cemented with an adhesive resin cement (Calibra, Dentsply, Konstanz, Germany) (Figures 16, 17, and 18).

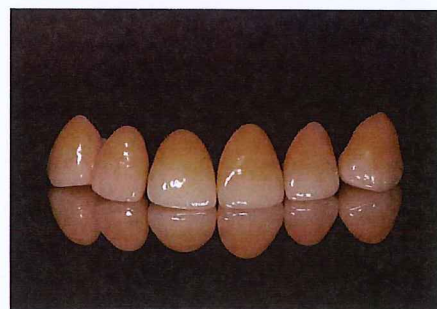
FIGURE 17: Empress crowns and bridge.

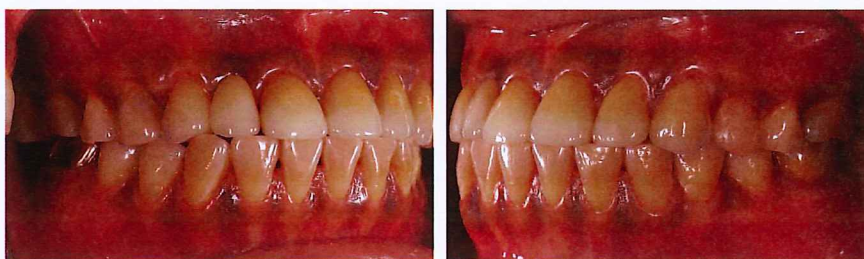
FIGURE 18: Postoperative lateral views showing successful reestablishment of the occlusion.

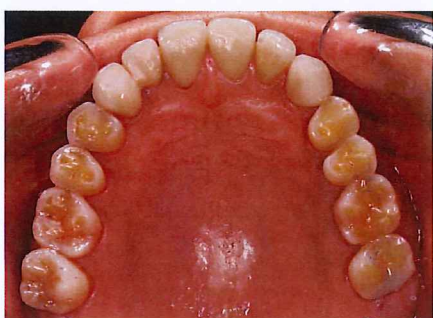
FIGURE 23: Upper occlusal view 5 years postoperatively.

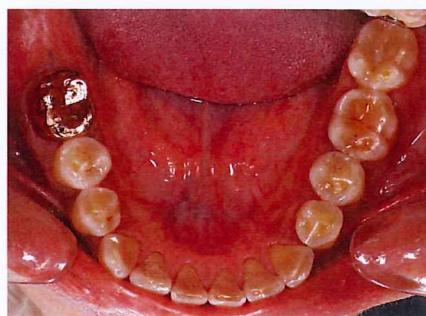
FIGURE 24: Lower occlusal view 5 years postoperatively.

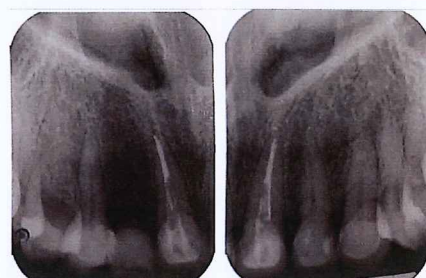
FIGURE 25: Periapical radiographs of the upper anterior teeth at review visits showing no periapical change or sign of root resorption.

The patient achieved good oral hygiene and maintained periodontal health during the follow-up period (Figures 19, 20, 21, 22, 23, and 24). No radiographic periapical change of the crowned teeth or resorption of the roots was observed at 5 years follow-up (Figure 25).

periapical change of the teeth concerned (Figure 25). There were no other complications, biological as well as mechanical, reported in this case during treatment and the 5-year follow-up period.
